L62X-A.04.19

Infotainment software update

Huracán EVO

2020

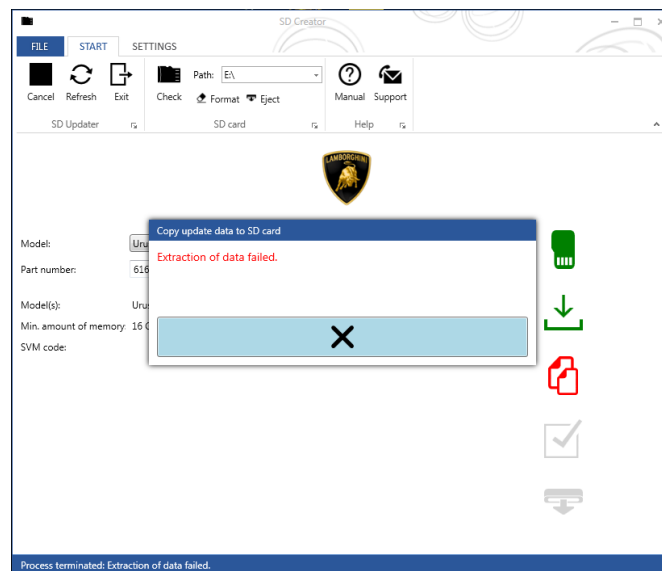
If the error shown in the following image occurs in the download from SD Creator, perform the instructions at the end of this document, in Trouble shooting section.

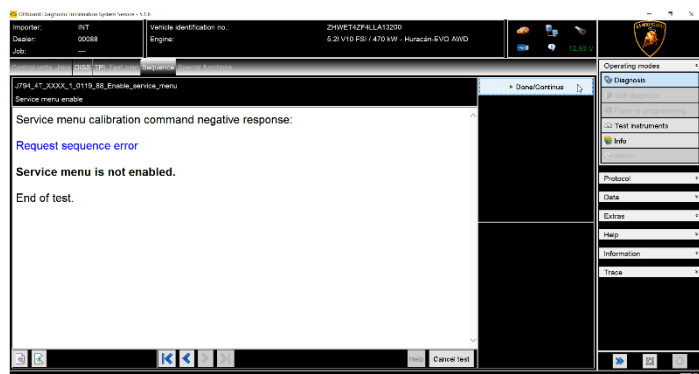
*If the following screen appears instead of the one indicated at the point **29**, it indicates that the Service Menu was already enabled before the procedure execution. You can continue anyway with the next steps.*

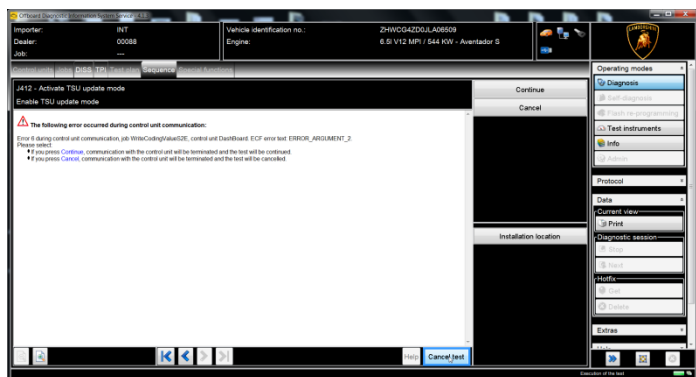
- i. If the following error screen is displayed, abort the guided function by clicking on "Cancel Test" and contact Technical Support.

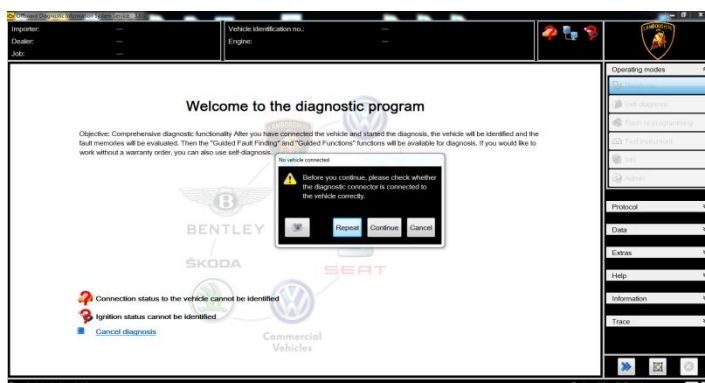
- ii. If an error is displayed that regards the hardware interface, and the "connection to vehicle" and "key state" icons appear as shown in the figure below:

- Click "Cancel";
- Repeat installation of the interface VAS5054/6154/6154A for the instructions in procedure (\*) "VCI Manager v2.0", selecting the right-hand "Extras" menu in ODIS and clicking on the "Diagnostic interface" button.

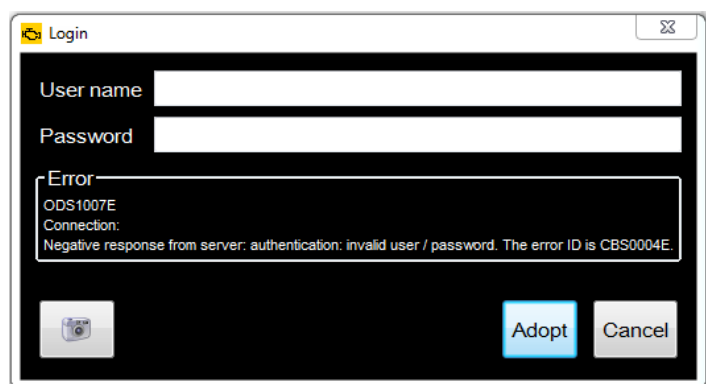
v. If the authentication error as shown in the following screenshot is displayed (error code: ODS1007E):

- Ensure you have a valid GeKo user account
- Ensure that the "GeKo" label is printed on the token you are using
- Ensure you have entered the correct password
- Click on "Cancel" and run the application test (see document "ODIS\_ControlloConnessione\_Server\_SVM\_2.0" (\*)).

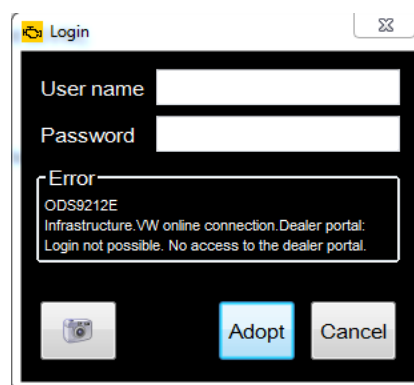
vi. If the infrastructure error as shown in the following screenshot is displayed (error code: ODS9212E):

- Ensure you have a valid GeKo user account

- Ensure that the "GeKo" label is printed on the token you are using
- Check that the Internet is set in ODIS settings and not CPN (see document "Set-up\_Iniziale\_ODIS\_2.0" (\*))
- Click on "Cancel" and run the application test (see document "ODIS\_ControlloConnessione\_Server\_SVM\_2.0" (\*)).

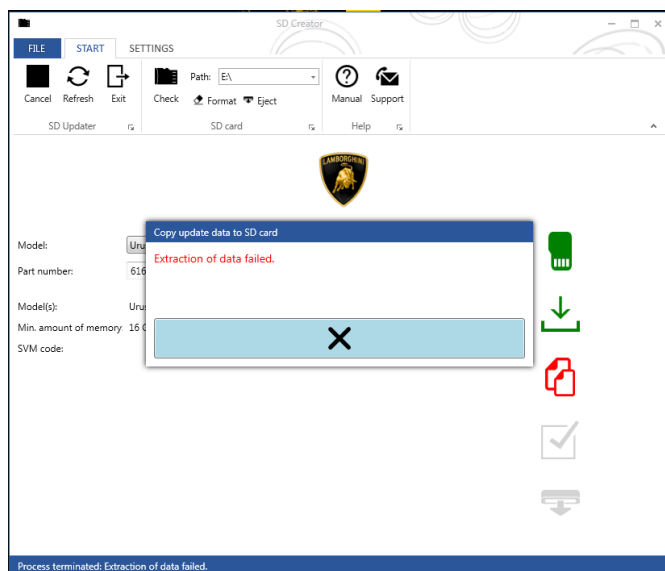
viii. If the following error should occur, it is necessary to follow the instructions given in

**BI.25.18** (Rev.02), which can be downloaded on the Lamborghini HUB portal:
