TSB - 2019 Ram 2500 OE Draglink Trimming

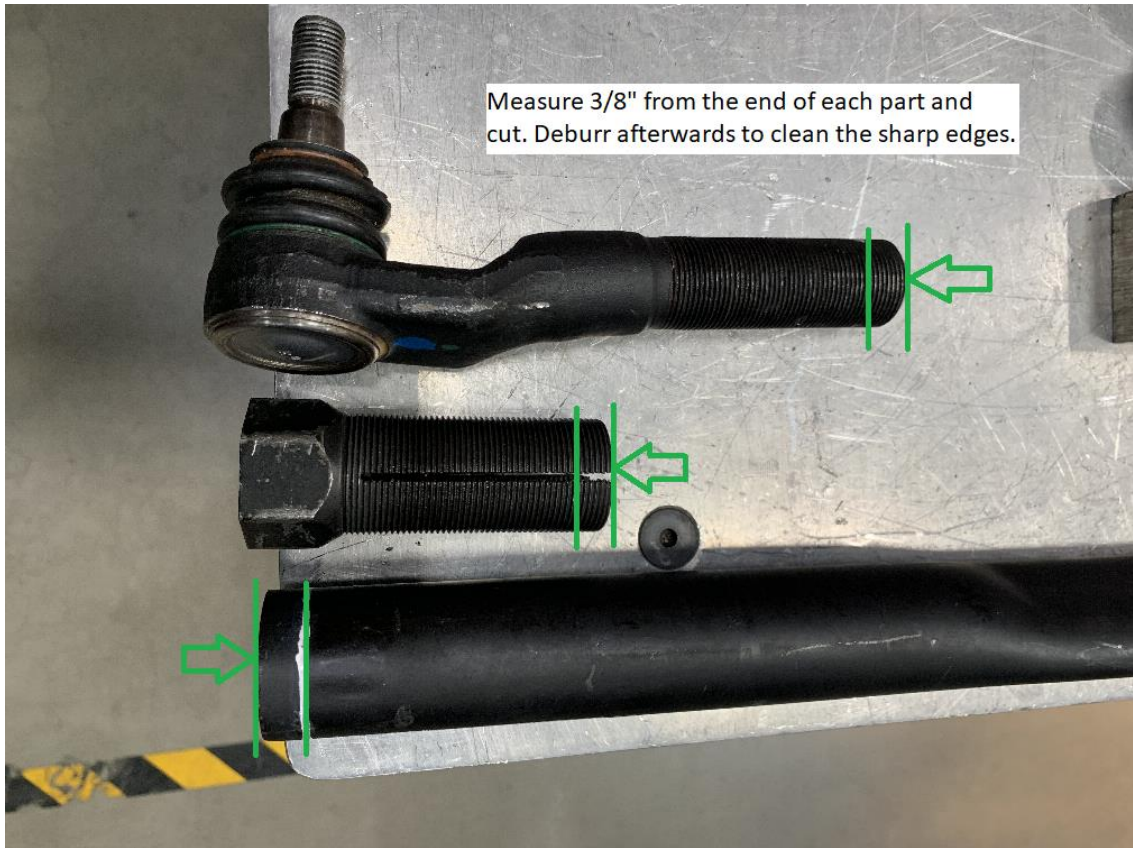
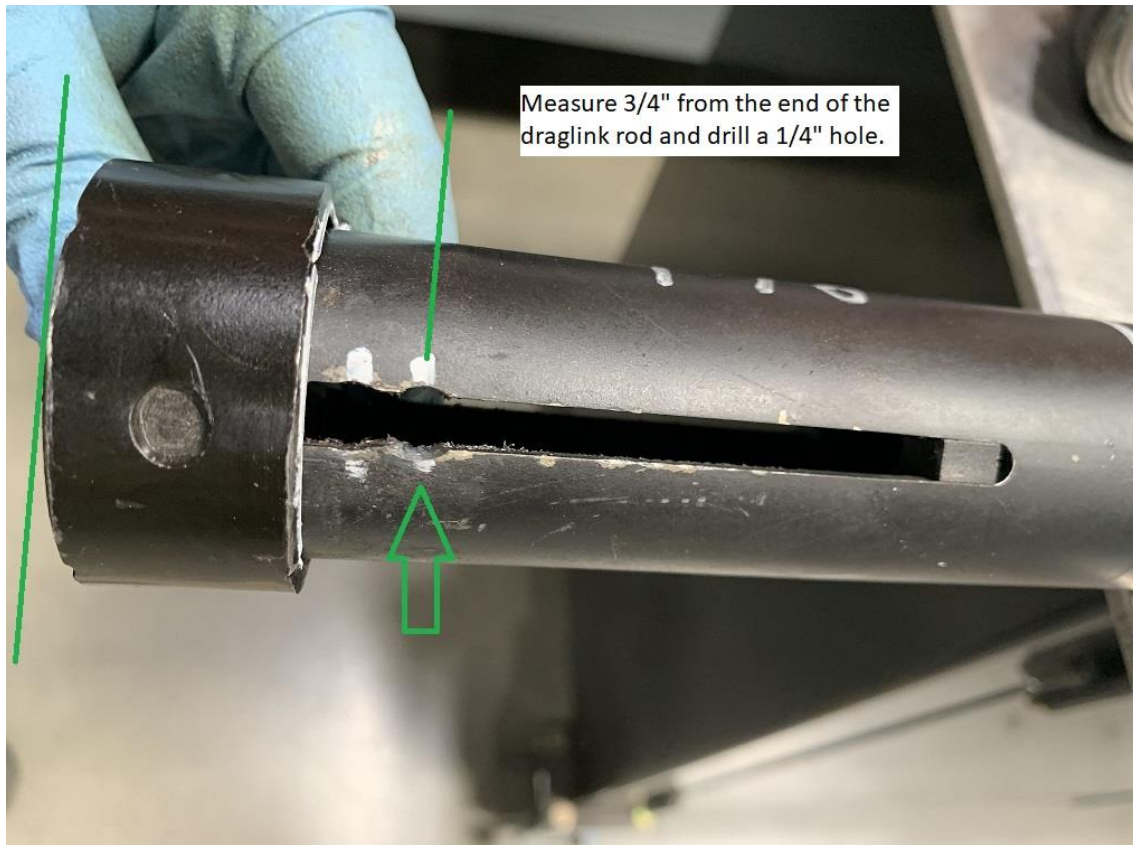
Pro Comp Performance Suspension has found instances on the 2019 Ram 2500 4WD that the drag link cannot be adjusted short enough to center the steering wheel. If you are experiencing this scenario, the below TSB advises a corrective action to get the vehicle aligned properly. Once an identifier can be determined, a running change will be released.

1. Remove the draglink from the vehicle.
2. Disassemble the tie rod, adjuster, and pinch clamp from the draglink. The pinch clamp can be lightly tapped off from the draglink rod. There is a small key on the top of the pinch clamp that keeps it in place on the draglink rod.

3. Measure in 3/8" from the end of the tie rod, adjuster, and draglink bar and mark a line for cutting.
4. Cut the three parts using the previously marked line. After cutting, deburr the surfaces to remove any sharp edges.

5. A new hole will be needed to reposition the pinch clamp. After cutting the draglink rod, measure in 3/4" from the end of the rod and mark a spot for drilling. Use a 1/4" drill bit to create a new hole for the pinch clamp to be reinstalled.

6. After the new hole has been created, reinstall the pinch clamp to the draglink bar.
7. Apply anti-seize to the tie rod and adjuster and reinstall them onto the draglink bar.

8. Reinstall the draglink to the vehicle and center the steering wheel. Torque all hardware to manufacture's specifications.
