Vehicles affected: P15: Senna

Location: Powertrain System – Cooling System

Concern: Coolant tank cap not locking in position

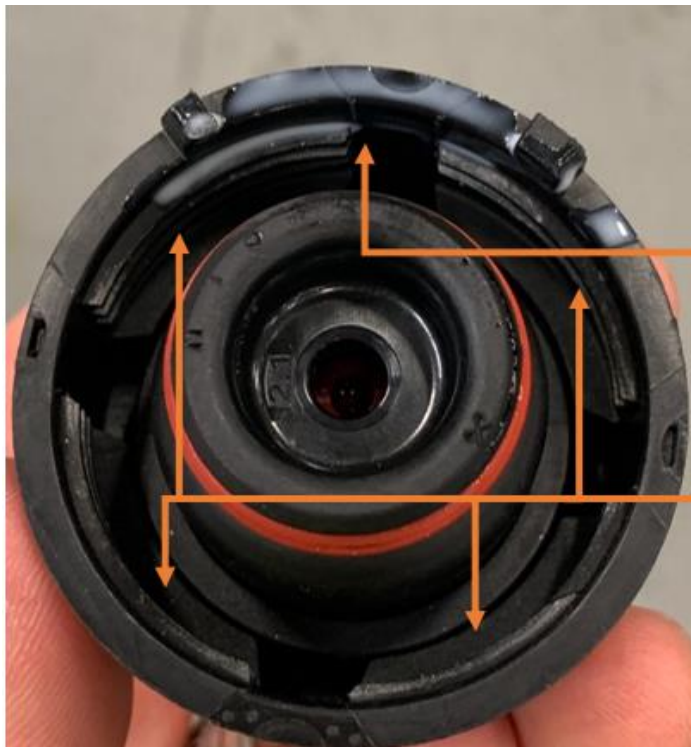
P80 applied to the locking mechanism area and inside edge.

Apply extra P80 around the threads if required.

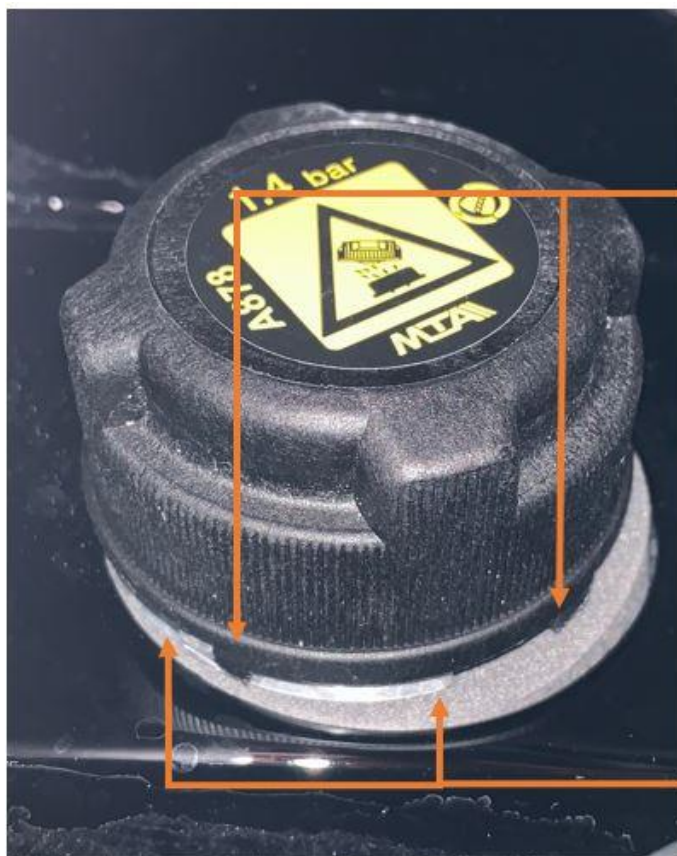
Coolant cap locking teeth – incorrect position to the header tank metal locking mechanism.

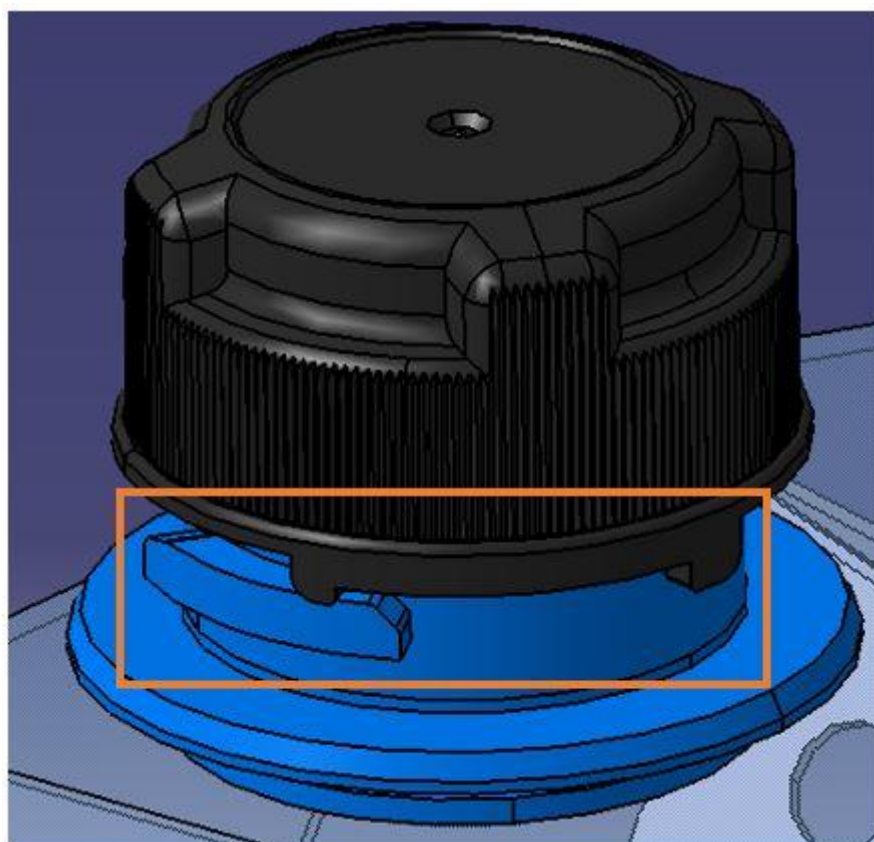
Header tank metal locking mechanism – the locking teeth on the cap have not fully engaged across the mechanism.
