Vehicles affected: P15: Senna

Location: Body & BIW – Active Aero

Concern: Airbrake Fault Warning Message on Driver Display

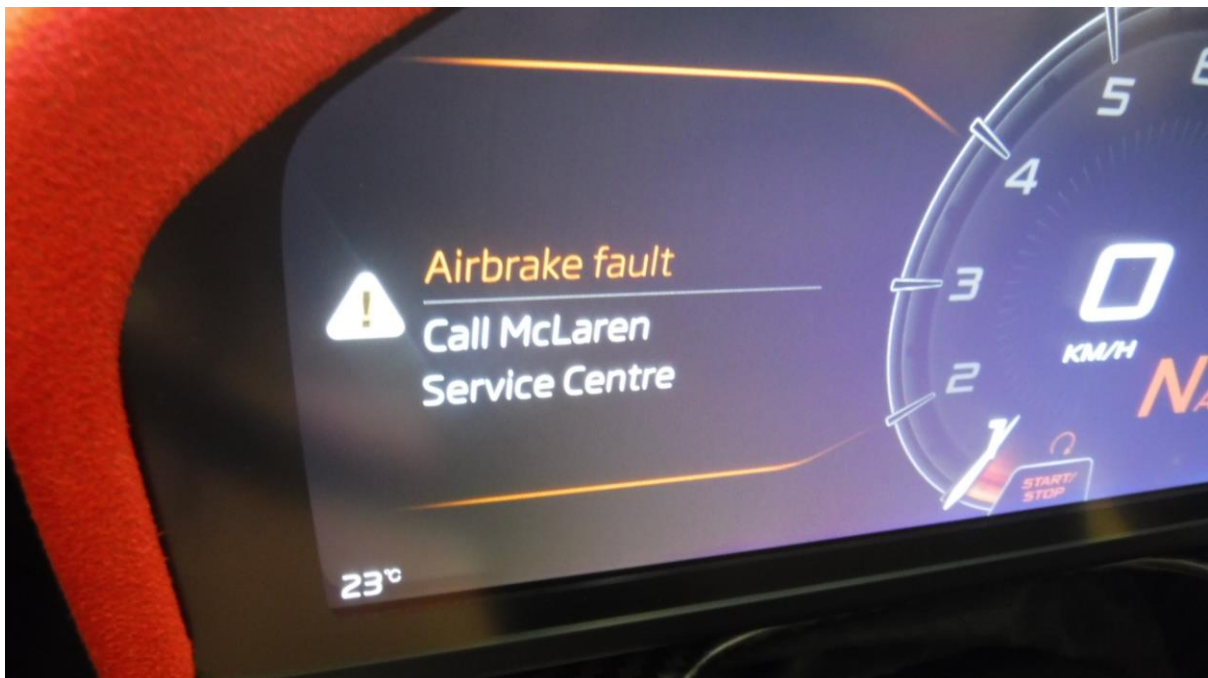
If the following error message is displayed in the driver's display, check in the TCU for DTCs.

If C100B21 Airbrake position 1 signal low and/or C101022 Airbrake position 2 signal high are logged, this can be due to the Drive Pin is not inserted into the sensor correctly. As a result the sensor's output will be at 0.00V.

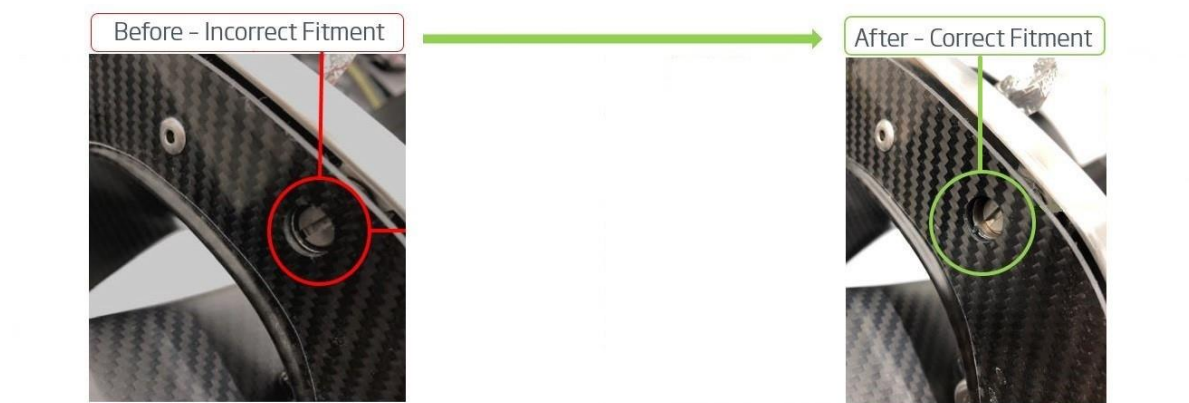
Check the fitment of the drive pin, verify the drive pin is inserted deep into the pylon to enter the sensor, the head of the drive pin should be 6.00 to 6.20mm from the side of the pylon.

If the drive pin is not inserted to the pylon, it will be necessary to adjust the fitment of the drive pin to the kinematic.

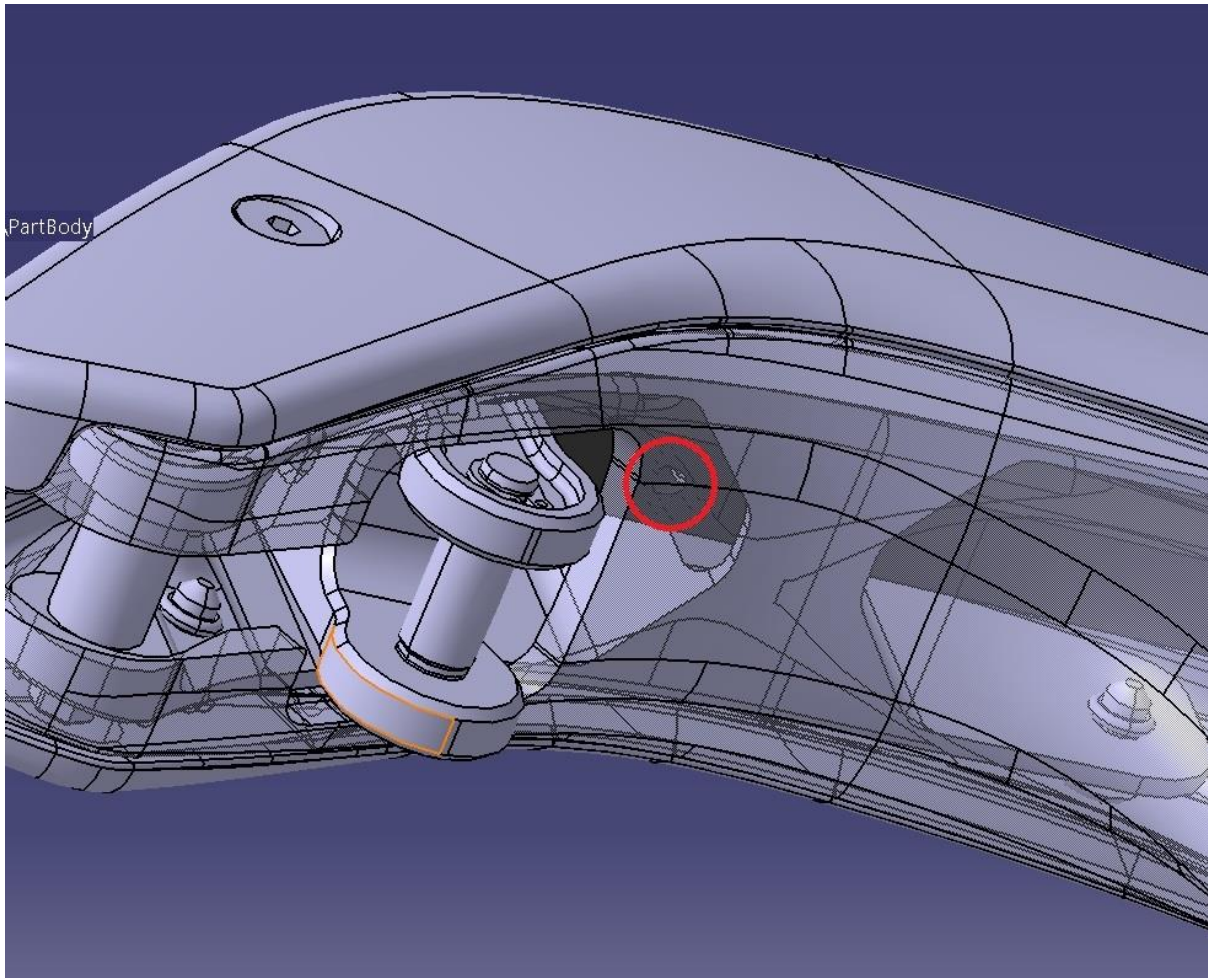
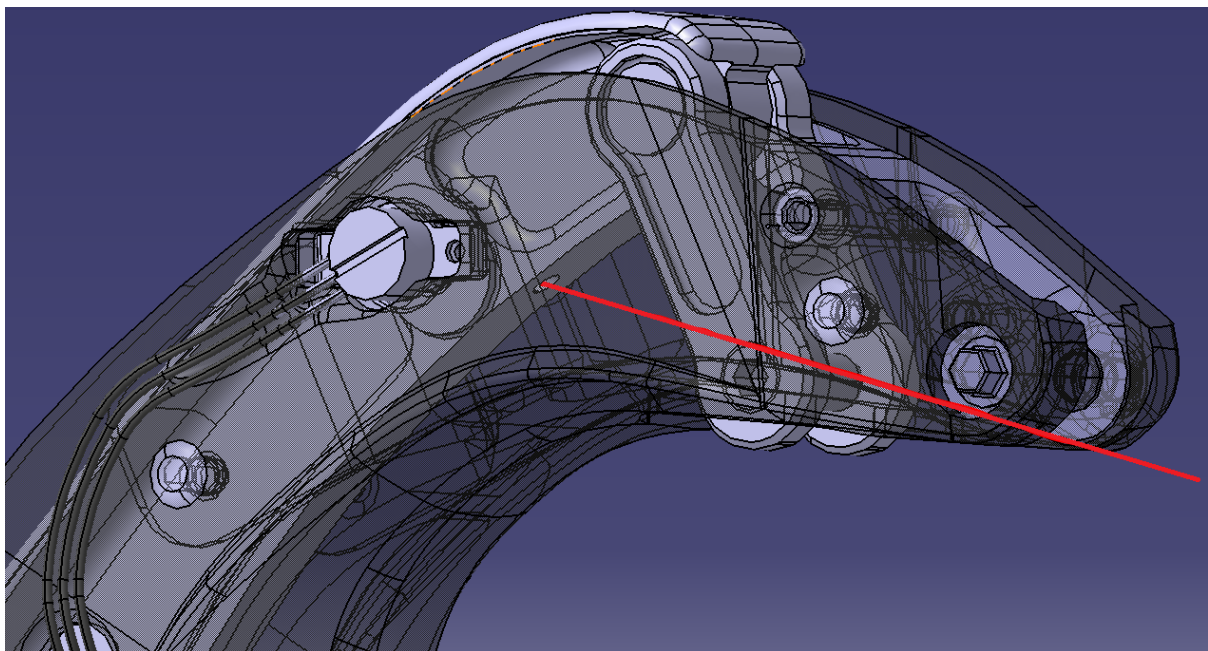
With the kinematic in the raised position it is possible to view from the underside of pylon the locking grub screw.

Release the grub screw from the kinematic and push the drive pin deep into the sensor until the depth of the drive pin head is 6.00mm to 6.20mm from the side of pylon. There should be no reason to remove the sensors.

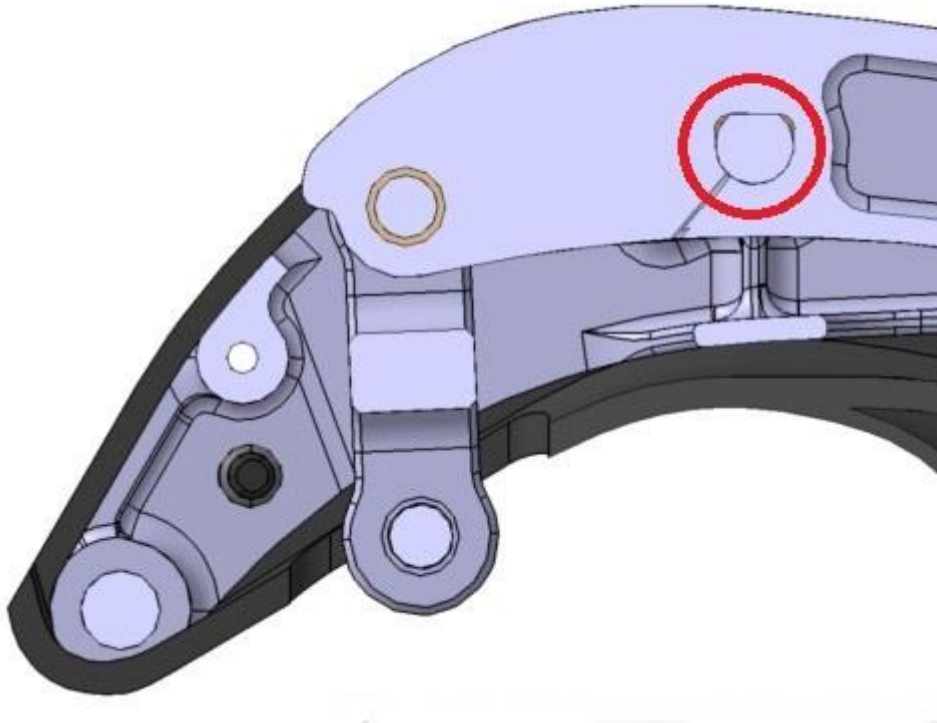
**Care Point:** The drive pin is not possible to rotate inside the Kinematic as it is with a D shape, do not attempt to move Kinematic by twisting the drive pin.

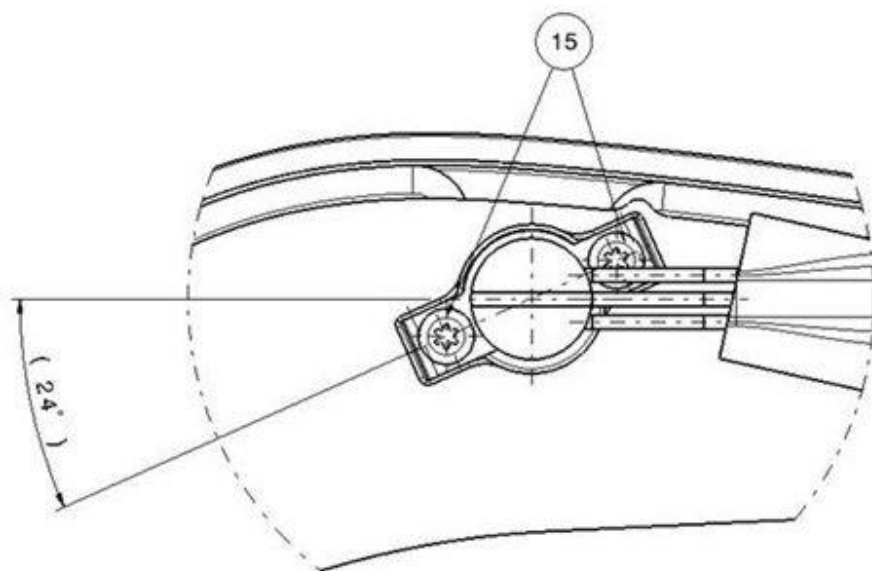
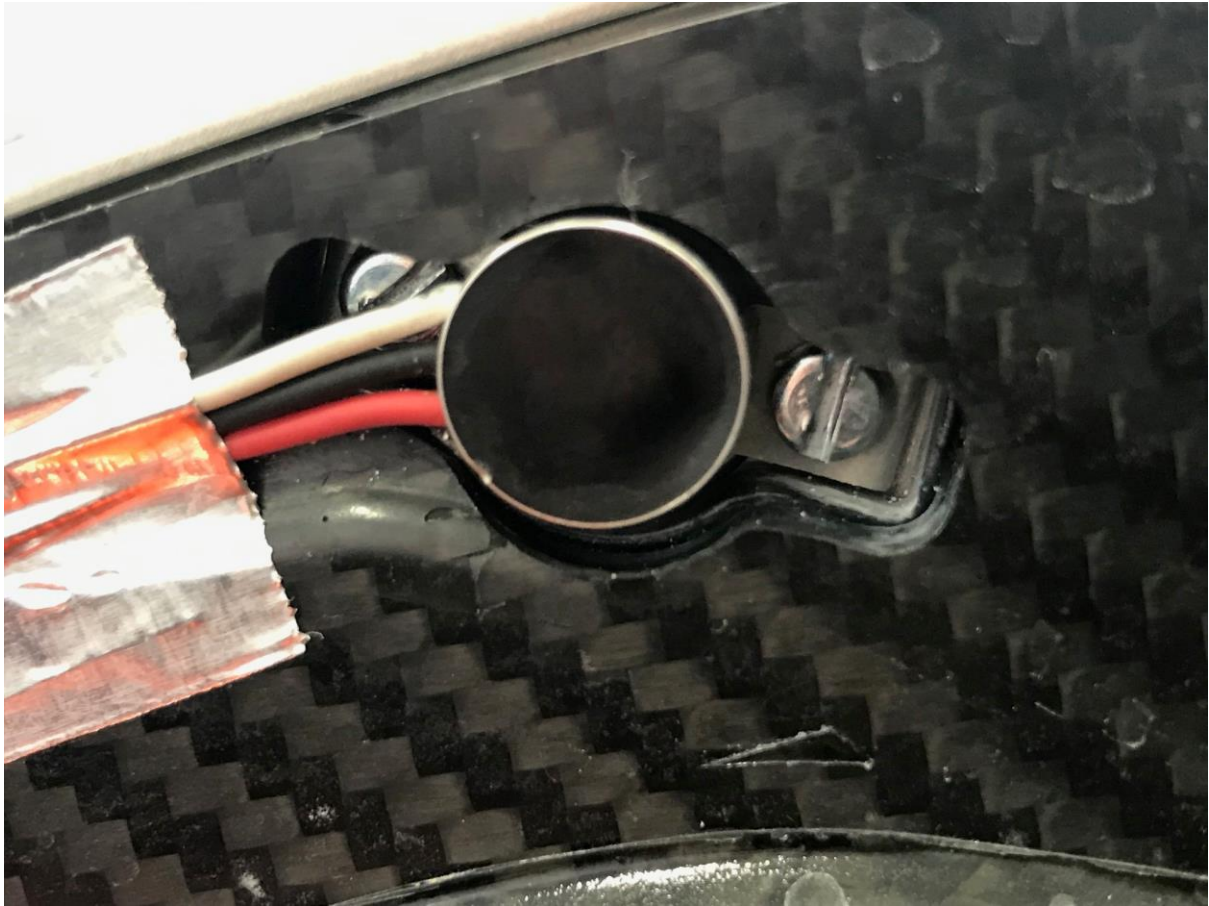
If the above procedure does not solve the problem or the Airbrake Position sensor was previously removed from the pylon, it will be necessary to align the sensors to give the correct voltage reading.

This is achieved by refitting the sensor to the pylon, with the mounting screws loose the body of the sensor is possible to rotate within its mounting plate.

- a) Negative probe = Connector TR001 - Pin 18
- b) Positive probe = Connector TR001 - Pin 45
- c) Rotate sensor until the voltage reading = 2.3V to 2.5V
- d) Tighten sensor mounting plate fixing screws to 1.6Nm.

- b) Positive probe = Connector TR001 - Pin 96
- c) Rotate sensor until the voltage reading = 2.7V to 2.9V
- d) Tighten sensor mounting plate fixing screws to 1.6Nm.
