Vehicles affected: McLaren GT

Location: Body Exterior – Ducts Vents and Floors

Concern: Guide vanes cannot be installed due to fixing hole not aligned with subframe hole

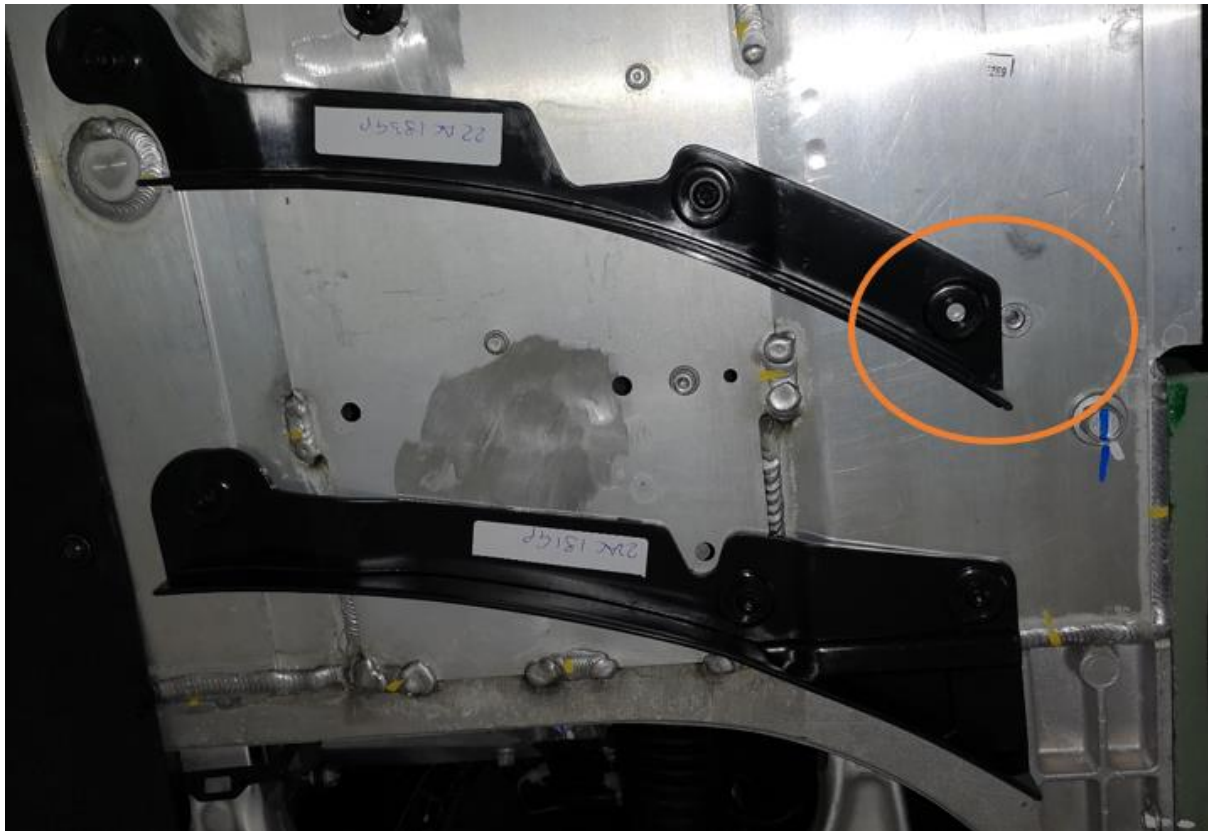
If during PDI of a McLaren GT it is noticed that the internal guide vanes cannot be installed due to the fixing hole not aligning with the subframe hole, please do not attempt to install the part.

The guide vanes provided with the vehicle are not within specification and therefore should not be used.

If the incorrect Internal guide vanes are supplied with the vehicle, order 22AD173GP and 22AD174GP as replacements and claim under warranty.
