McLaren 600LT Front Wheel Speed Sensor wiring rework

Bulletin type: Service Campaign Bulletin
Reference number: SCB13 M 014
Campaign reference: 04Q
Attention: Retailer Service Managers and Retailer Technicians.
Affected vehicles: 600LT
Situation: Incorrect wiring routing causing ABS warning lamp to be illuminated
Procedure: To action during next Retailer visit.
Please refer to the information outlined in this document to re-route the front wheel speed sensor wiring
Date: 4th July 2019

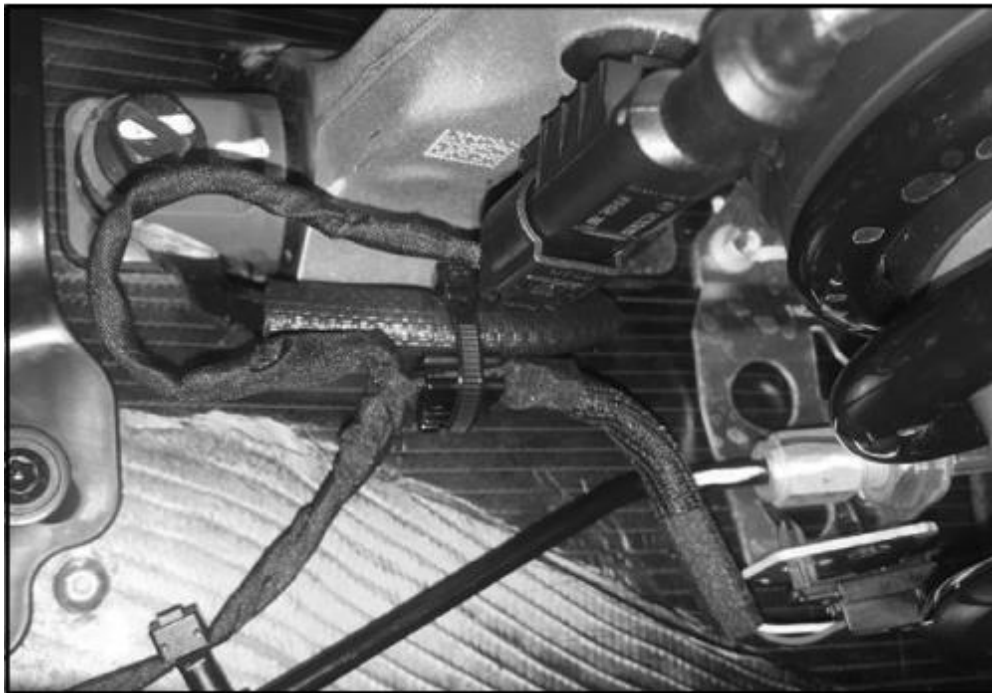
McLaren Wheel Speed Sensor

McLaren Automotive has identified through our continuous product quality monitoring, that a number of McLaren 600LTs have an incorrect routing of the front wheel speed sensor harnesses. This could cause the connector or wiring to detach causing an ABS warning on the cluster.

To enable this repair, an adjustment to the protective covering and routing of the harness is required. Document SCB 13 M 014 WI (attached with this bulletin), contains the relevant work instruction and care points to ensure the required repair is carried out to bring the vehicle up-to the current manufacturing standard.
