# McLaren Senna – Rear Wing End Plate Rework

| <b>Reference number:</b> | SCB 15 A 001 |
| <b>Situation:</b> | Potential for insufficient tightening torque of the screw fixings for the Rear Wing End Plates |

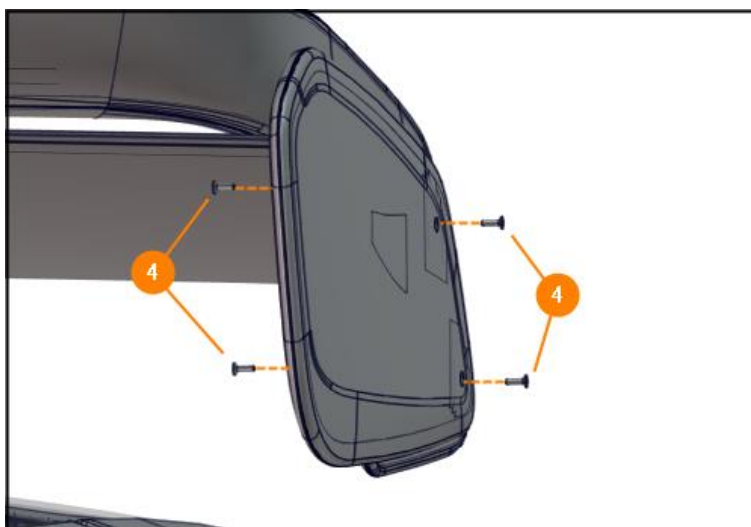
McLaren Automotive has identified through our continuous product quality monitoring, that a number of McLaren Senna vehicles may have an insufficient tightening torque of the screw fixings on both of the Rear Wing End Plates. This could result in the fixing screws and end plate(s) to become loose on its mounting point.

1 Layout overview of Rear Wing End plate and fixing screws (4)

To carry out the required re-work, addition of thread locker (equivalent to Loctite 272 specification) to all of the fixing screws (on both sides) is required, as well as ensuring both Rear Wing End Plates are correctly positioned, and the fixings screws are tightened to the specified torque of 1.5Nm.
