TECHNICAL INSTRUCTIONS
FOR
SPECIAL SERVICE CAMPAIGN K0B
MILLIMETER WAVE RADAR SENSOR

CERTAIN:
2018 – 2019 TACOMA
2018 – 2019 TUNDRA

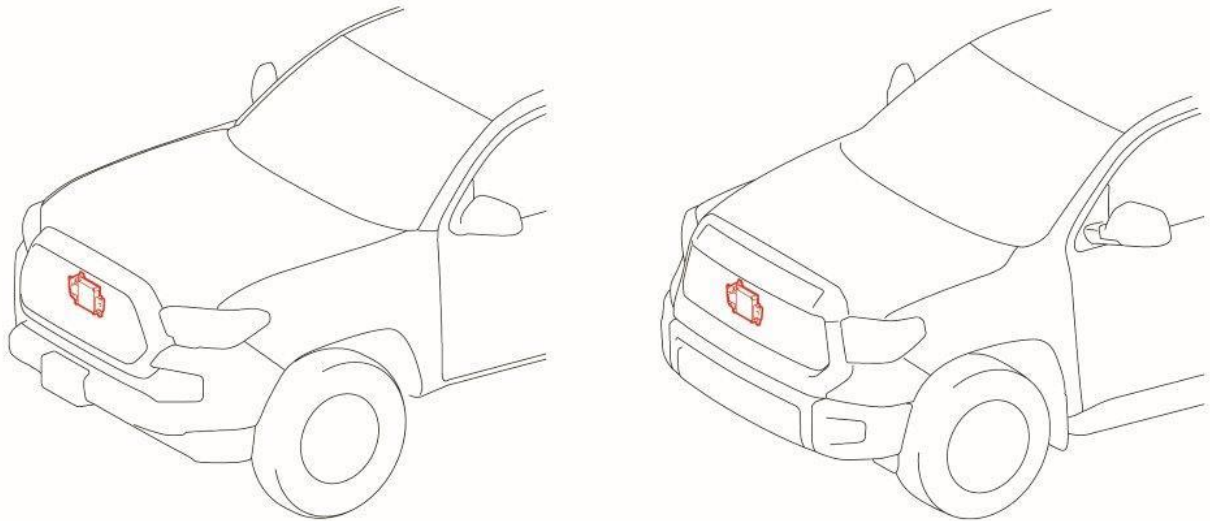
The involved vehicles are equipped with a Pre-Collision System (PCS) that may automatically apply the brakes if the system detects a potential collision. Due to the mounting of one of the system's sensors, it is possible for water to enter the sensor. This can lead to PCS deactivation or inadvertent brake activation resulting in limited deceleration for a short duration of time.
