GLOBAL SAFETY FIELD INVESTIGATIONS  
DCS4952  
URGENT - DISTRIBUTE IMMEDIATELY

Subject: N182201852 - Service Update  
Navigation Map SD Card Does Not Read

Models: 2019 Chevrolet Silverado 1500 (New Model)  
2019 GMC Sierra 1500 (New Model)

## N182201852 - Navigation Map SD Card Does Not Read

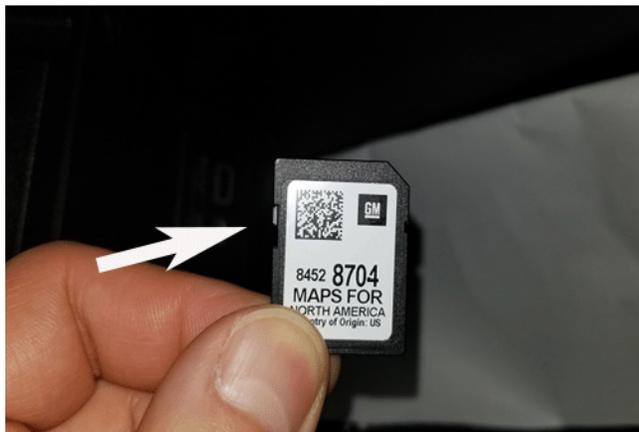
5207511

**Note:** When inserting the SD card, make sure that the switch is in the correct position (UP). Insert the card straight and not on an angle, since the switch may rub on the side of the card slot and change position.

**Correct** switch position (up)

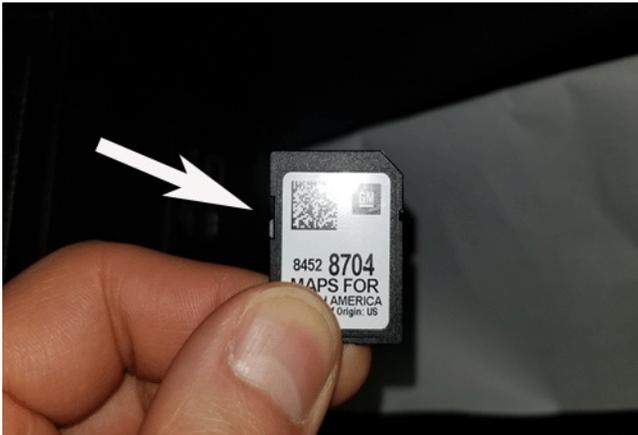
5207515

**Incorrect** switch position (down)
