GLOBAL SAFETY FIELD INVESTIGATIONS
DCS4928
URGENT - DISTRIBUTE IMMEDIATELY

Subject: A182195730 - Service Update
Incorrect OnStar Button Icon

Models: 2019 Chevrolet Spark Equipped with OnStar (UE1)

A182195730 Incorrect OnStar Button Icon

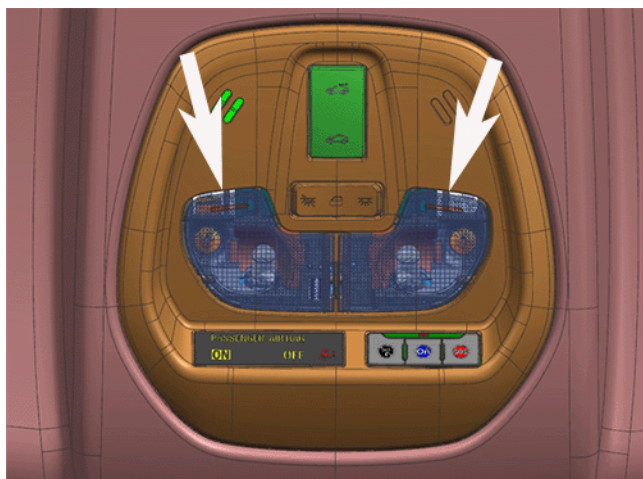
With Sunroof

Condition	The overhead console OnStar Voice command button displays the incorrect icon.
Correction	Dealers will replace the OnStar Communication Control Call switch with a new switch containing the correct graphic on the button.

1. Remove the center reading and courtesy lamp lens using an appropriate trim removal tool.
