*NUMBER:* 25-001-19

Instrument Panel Cluster (IPC) Message about Diesel Particulate Filter (DPF) Regeneration

2019 - 2020	(KL)	Jeep Cherokee
2019 - 2020	(JL)	Jeep Wrangler

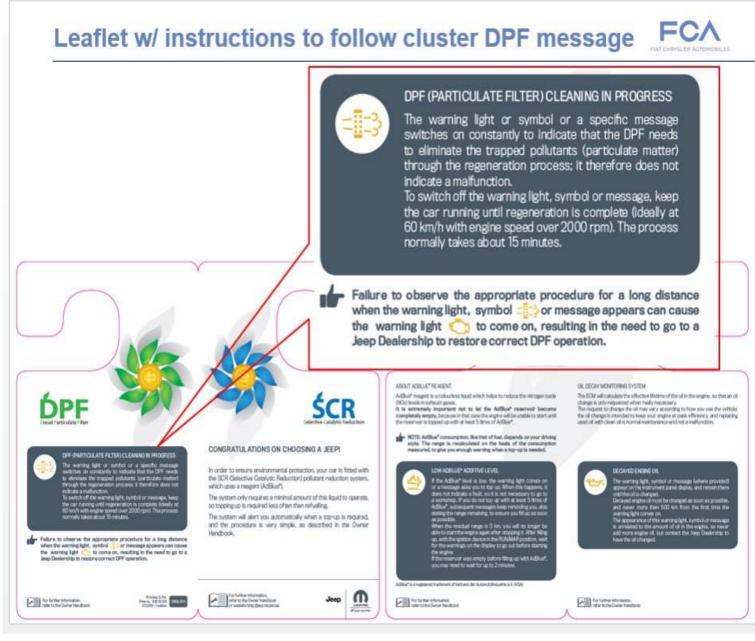
After normal diagnosis has been performed and it is determined that the customer neglected the IPC warning message about DPF regeneration, this will result in customer pay to have a forced regeneration procedure performed instead of the normal regeneration as recommended in the user manual and in the information leaflet provided with their vehicle upon delivery (Fig. 1).

Fig. 1 Leaflet for DPF Regeneration Provided to Customer Upon Vehicle Delivery
