NUMBER: 23-031-19

Water Leak At Lower Center Of Windshield

2019 (JL) Jeep Wrangler

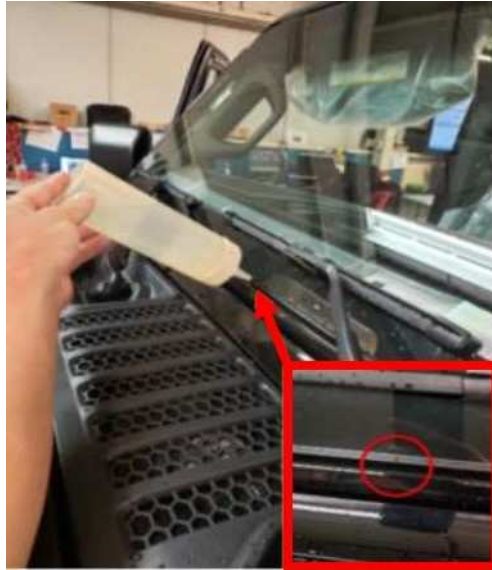
1. Apply soapy water into the molding gap at the bottom center windshield glass (Fig. 1) .

Fig. 1
Inspect for Leaks

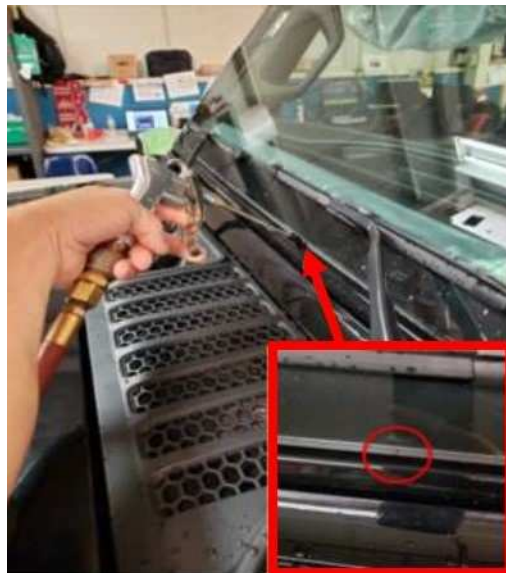
2. Apply compressed air to the center lower windshield molding gap (Fig. 2) .

Fig. 2
Apply Compressed Air

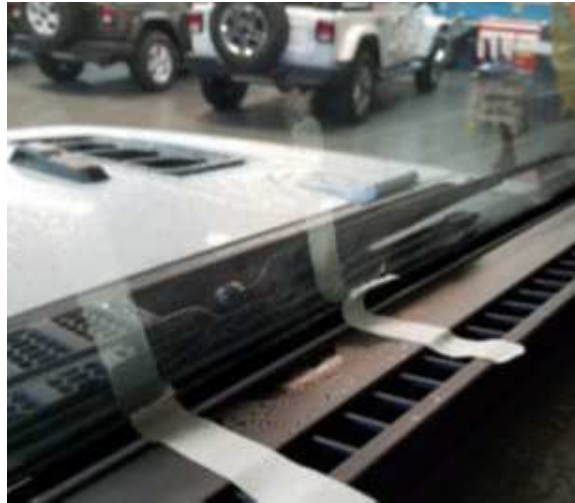
3. Look for signs of water or bubbles on the dash top. Use masking tape to isolate area (Fig. 3) .

Fig. 3
Inspection Area

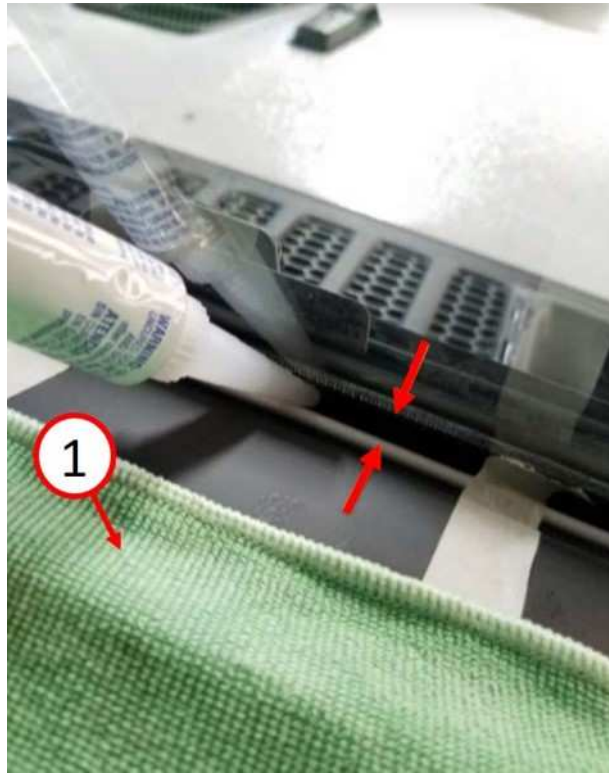
Fig. 4
Apply Sealer

1 - Masked Dash Area

3. Mask the dash to prevent excess material contacting the interior (Fig. 4) .

4. Apply a generous amount of sealer to the area between the glass and windshield frame. Follow product guidelines for curing (Fig. 4) .
5. Re-test the area after the silicone has dried per the manufactures specified dry time.
