**NUMBER:** 08-107-19 REV. A

Positive Generator Battery Cable Location Re-Route

2019 (BV) Jeep Renegade

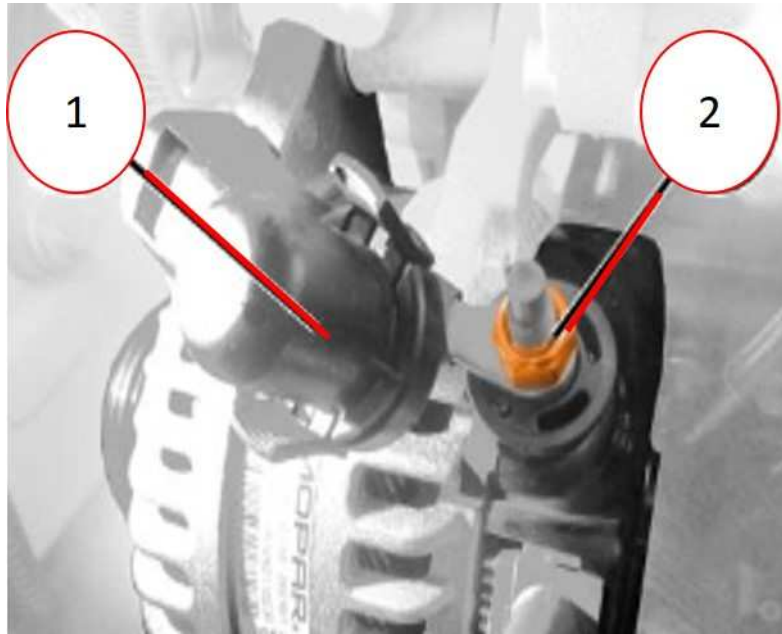
**Fig. 1**  
**Generator Positive Cable**

The generator positive battery cable may come into contact with the generator drive belt pulley.

- Remove the protective cap and remove the nut for the battery positive electrical connection at the generator (Fig. 1).

- Connect the positive battery cable to the generator, then tighten the positive battery nut to 15 N·m (133 in. lbs) (Fig. 1).
- Connect the negative battery cable. If equipped with an Intelligent Battery Sensor (IBS), connect the IBS connector. Refer to the detailed service procedures available in DealerCONNECT> Service Library under: Service Info> 08 - Electrical / 8F - Engine Systems / Battery System / Cables, Battery / Removal and Installation> Negative Cable.
- Cycle the ignition ON/OFF/ON.
