VOLVO CAR SERVICE AND PARTS BUSINESS

### **Technical Journal**

#### TITLE: Loose Outer Window Seal on Door

REF NO:	ISSUING DEPARTMENT:	CAR MARKET:		
TJ 35038.1.1	Technical Service	United States and Canada		
3 US 7	PARTNER:	ISSUE DATE:	STATUS DATE:	
	7510 Volvo Car USA	2019-07-16	2019-07-19	
FUNC GROUP: 8451	FUNC DESC: Sealing moulding for side door	Page	1 of 7

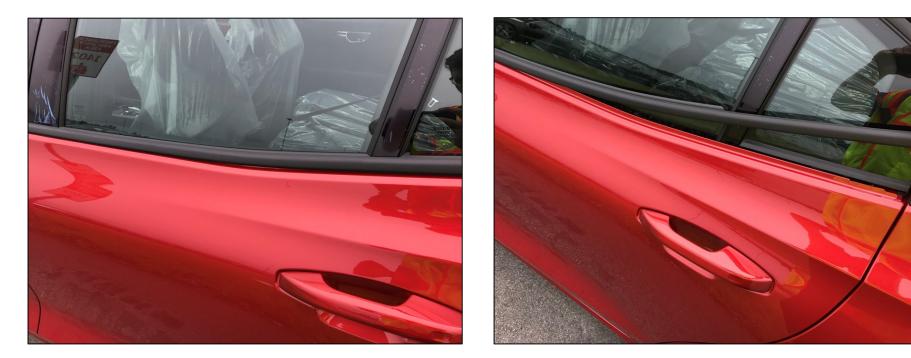
# LOOSE OWS REWORK

1. Identify car needing repair (loose OWS).

2. Unseat OWS enough to apply tape.
