Hard to fill fuel due to frozen filler pipe

REF NO: TJ 34215.3.1	ISSUING DEPARTMENT: Technical Service	CAR MARKET: United States and Canada	
PARTNER: 3 US 7510 Volvo Car USA		ISSUE DATE: 2019-04-02	STATUS DATE: 2019-04-11
FUNC GROUP: 2340	FUNC DESC: Fuel tank, fuel lines, evaporator system	Page 1 of 3

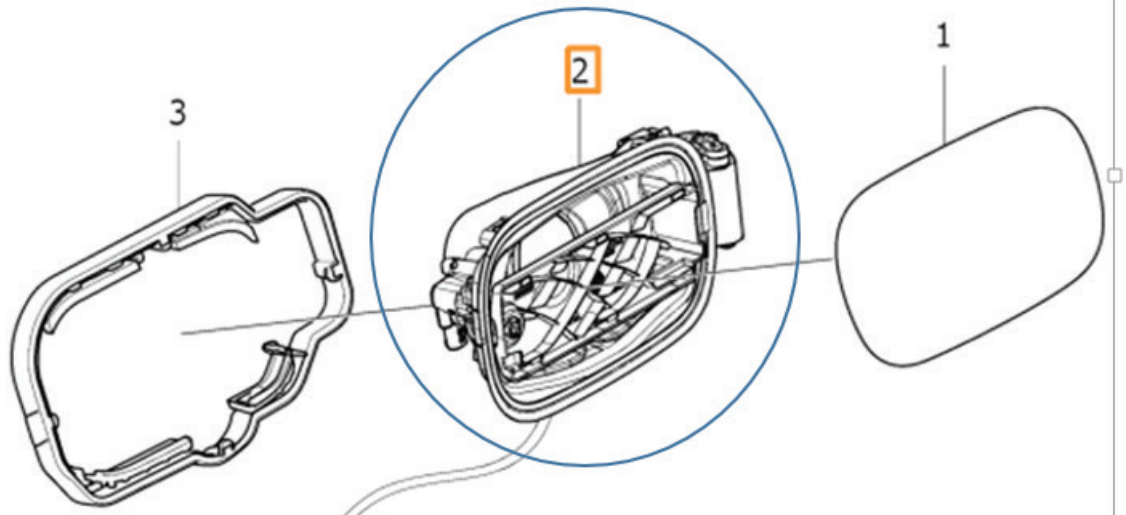
File Name	File Size
Fuel hatch.PNG	0.0780 MB

If customer complains about difficulties to refuel due to frozen filler pipe, please follow advise under “service”.

Replace the fuel hatch according to VIDA. New fuel hatch was released 2018w40(90 cluster) with new sealing concept. See attachment.
