Technical Journal

Hard to fill fuel due to frozen filler pipe

REF NO: TJ 34215.3.0	ISSUING DEPARTMENT: Technical Service	CAR MARKET: United States and Canada		
3 US 7	PARTNER: 7510 Volvo Car USA	ISSUE DATE: 2019-03-25	STATUS DATE: 2019-04-02	
FUNC GROUP: 2340	FUNC DESC: Fuel tank, fuel lines, evaporator svstem	Page	1 of 3

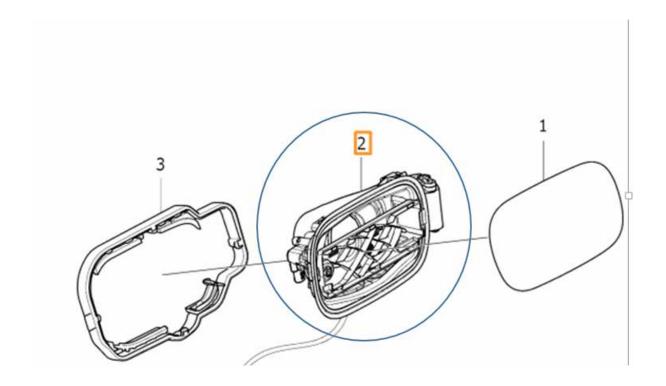
File Name	File Size
Fuel hatch.PNG	0.0780 MB

If customer complains about difficulties to refuel due to frozen filler pipe, please follow advise under "service".

*New fuel hatch for XC60, V60 and V60CC was released 2019w11.

Replace the fuel hatch according to VIDA. New fuel hatch was released 2018w40(90 cluster) with new sealing concept. See attachment.
