Technical Information Bulletin

E216

MY17/18 PACCAR MX-11 EGR DTCs P103C, P1711, P1719, and/or P3818; DPF/SCR restrictions; and/or high oil consumption.

3/7/2019

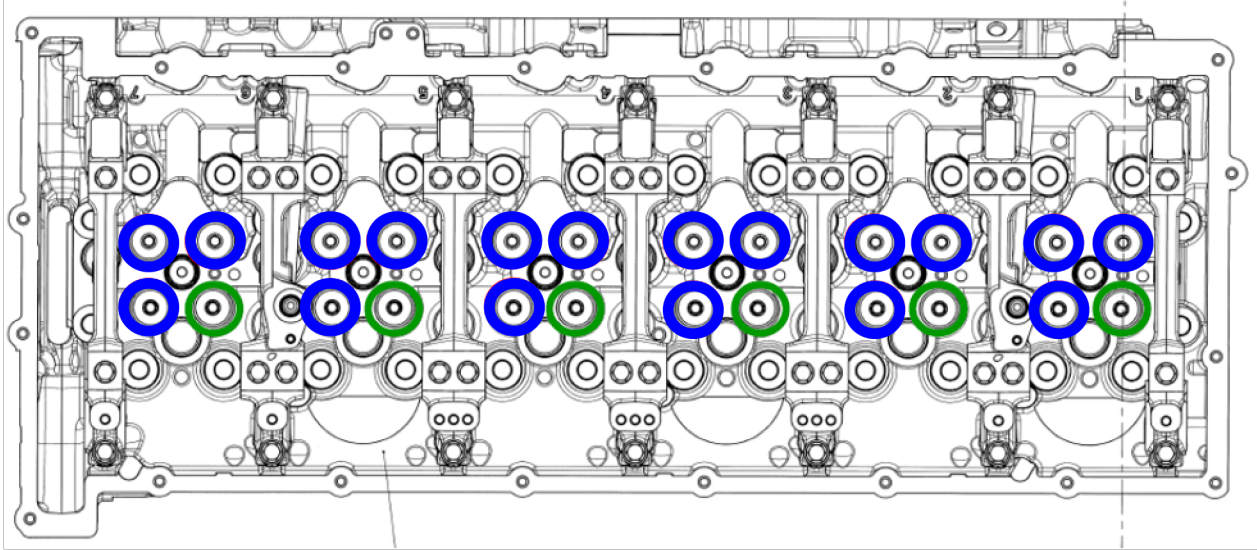
Figure 1 Valve Guide Seal Locations

2183405 on DEB Exhaust valve
-

1913734 seal + 2183697 washer

1. If directed to replace the valve guide seals, replace the four seals as described in the image below. See Engine Rapido for instructions and refer to the following figure for the location and part number of the new seals and spring washer.
 - As you replace the seals, inspect the valves for visible wear. Polishing and light wear in this area is normal. Heavy wear and galling (as pictured) is cause for replacement. Valves with visible wear must be replaced. Contact RESM if valve stem wear as shown in Figure 2 below is found.
