Service Bulletin

Subject: Rattle Noise in Passenger or Driver Upper B-Pillar Area

Brand:	Brand: Model:		Model Year:		VIN:		Transmission:
Branu.	woder.	from	to	from	to		
Cadillac	XT4	2019	2019			All	All

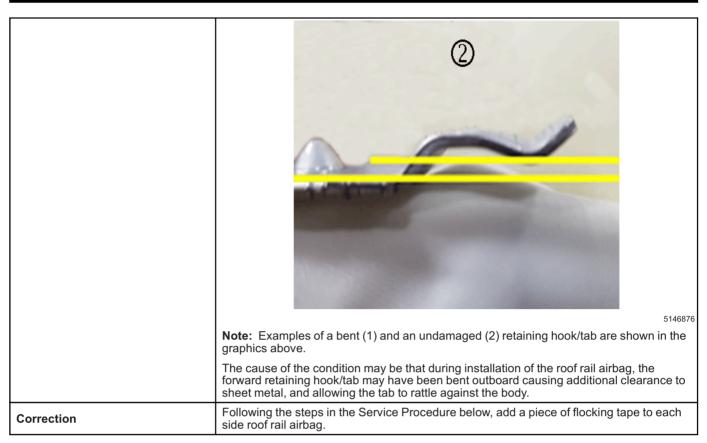
Involved Region or Country	North America and N.A. Export Regions
Condition	Some customers may comment on hearing a rattle noise coming from the passenger or driver upper B-Pillar area.
Cause	<image/> <image/>
