Service Bulletin

File in Section: -
 Bulletin No.: 18-NA-288
 Date: September, 2018

Subject: Rocker Panel Molding Gap at Rear

Brand:	Model:	Model Year:		VIN:		Engine:	Transmission:
		from	to	from	to		
Buick	Regal GS	2018	2019			All	All

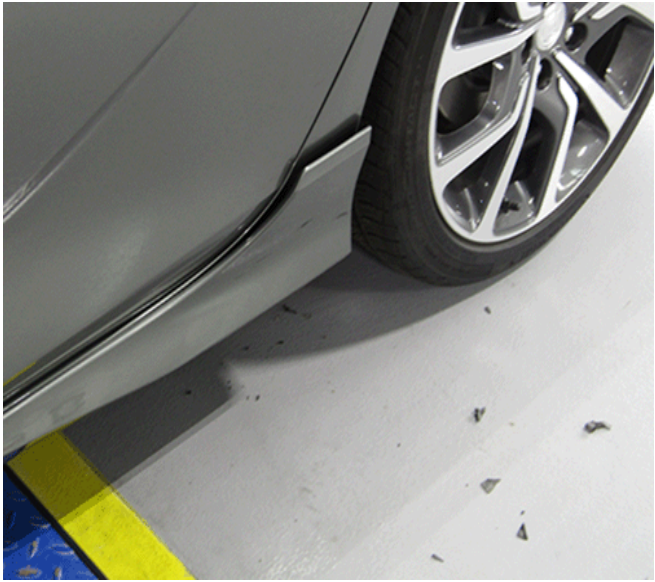
<p style="text-align: right; font-size: small;">5147445</p> <p>Some customer may comment on seeing the rocker panel molding gapping to body at the rear wheel opening, on one or both sides of the vehicle.</p>
Cause	The cause of the condition may be due to thermal expansion and contraction. The adhesive tape retaining the molding is stretching and pulling away from the body.
Correction	Re-secure BOTH the left and right side rocker moldings, following the Service Procedure below.
