Technical Information Bulletin

15-027

T680/T880 Power Steering Sealing Plug Seated Incorrectly

ZF Steering Gear Boxes May Develop a Leak Due to an Improperly Installed Plug

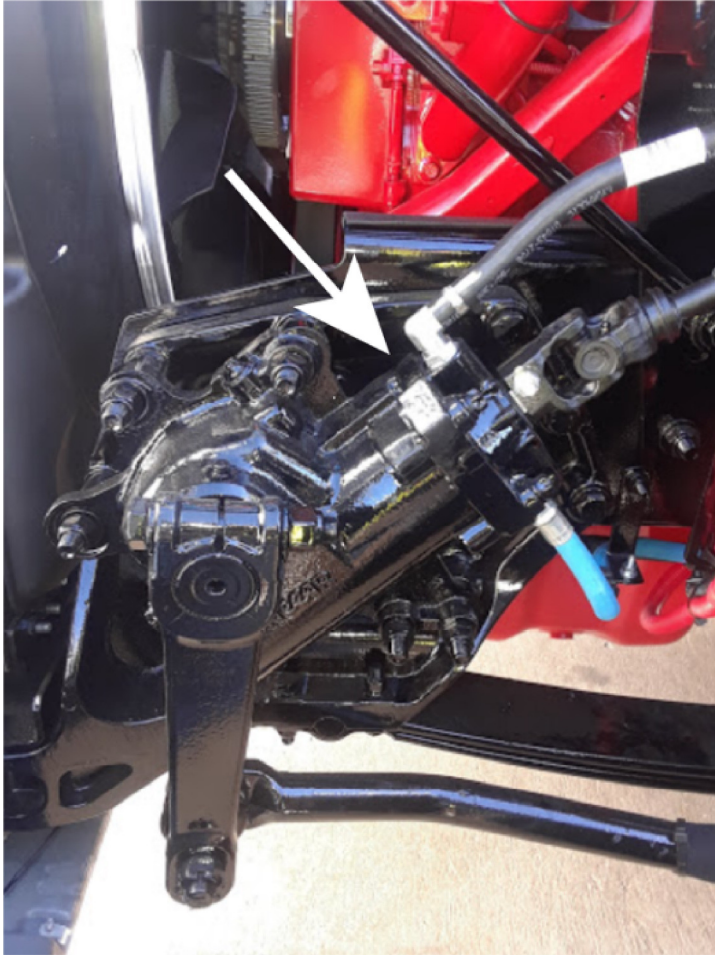
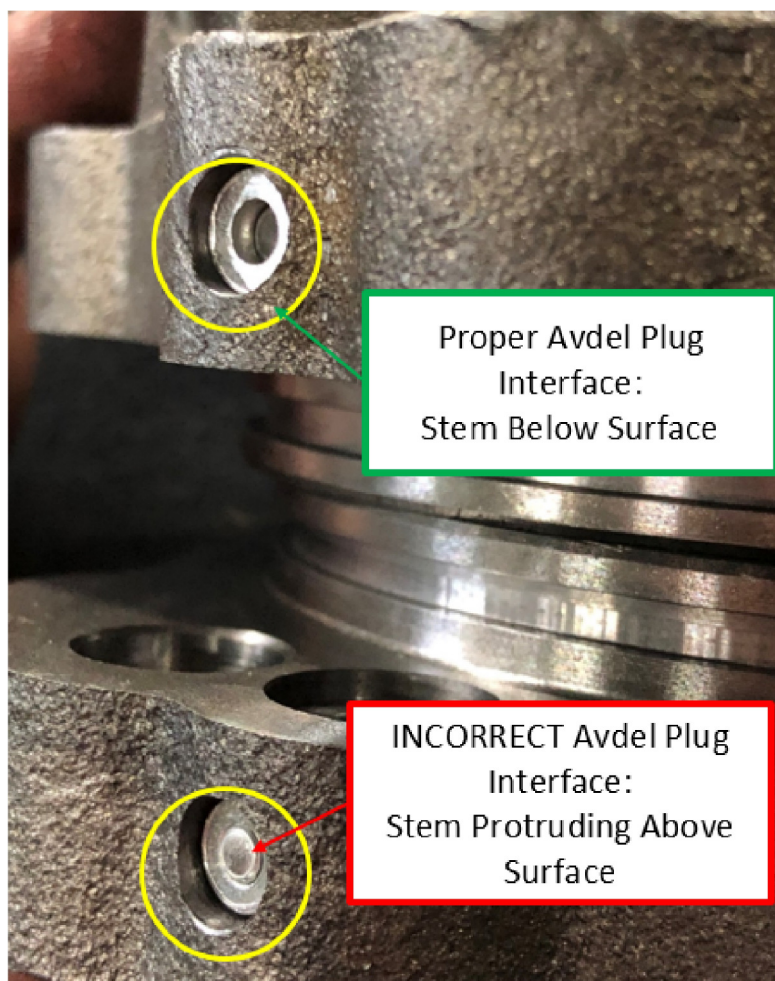
- Inspect the Avdel plug on the steering gear. The Avdel plug is found on the input shaft end of the gear, against the frame in the location marked below.
 - A properly installed Avdel plug will have the stem below the surface of the plug face.
 - An improperly installed plug will have the stem protruding from the face of the plug.

2. If the stem is protruding from the face of the plug, replace the steering gear.

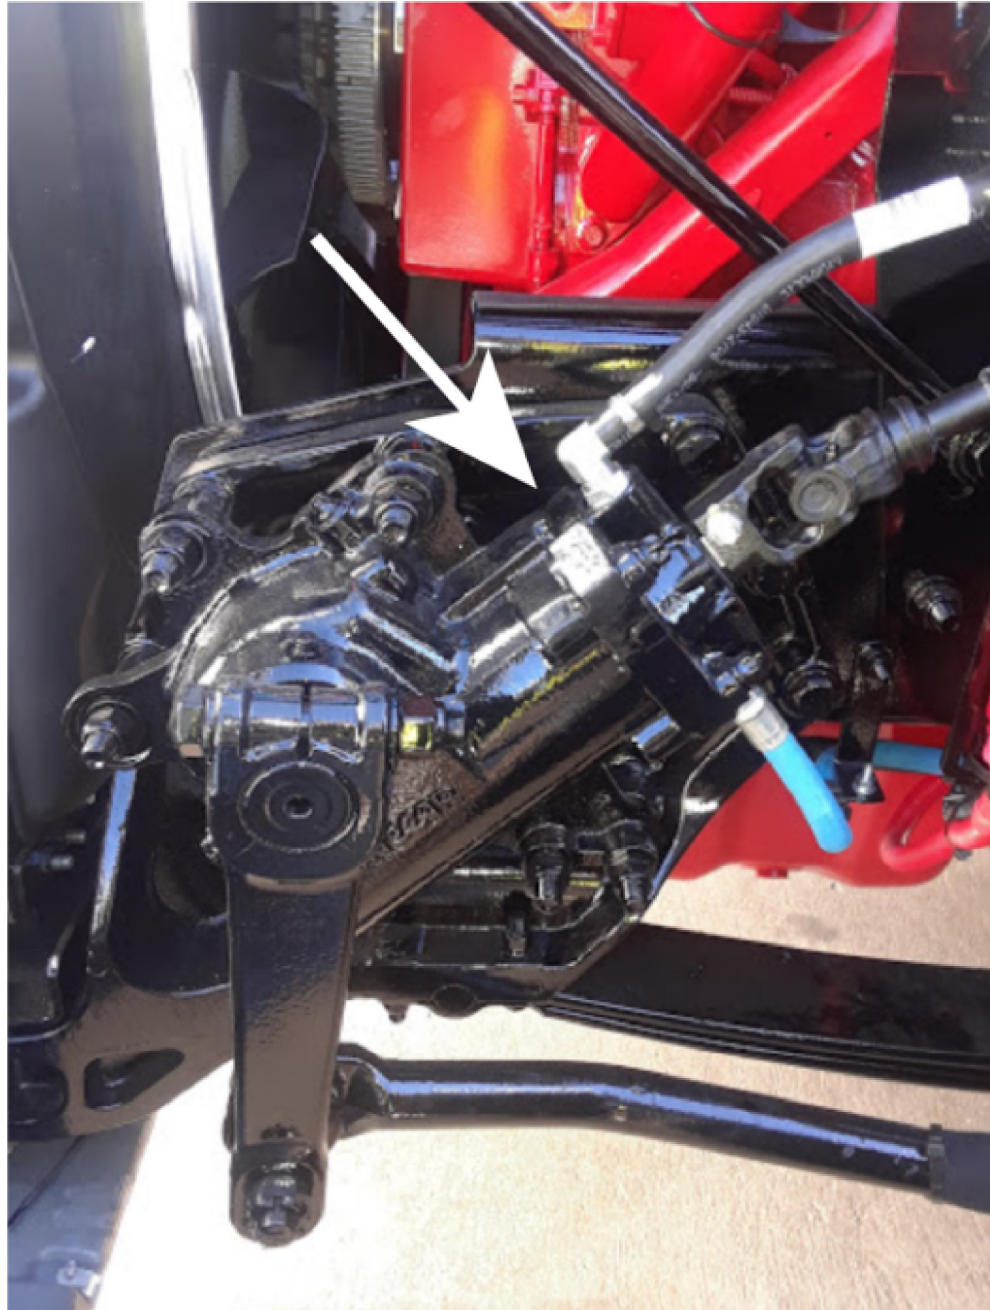
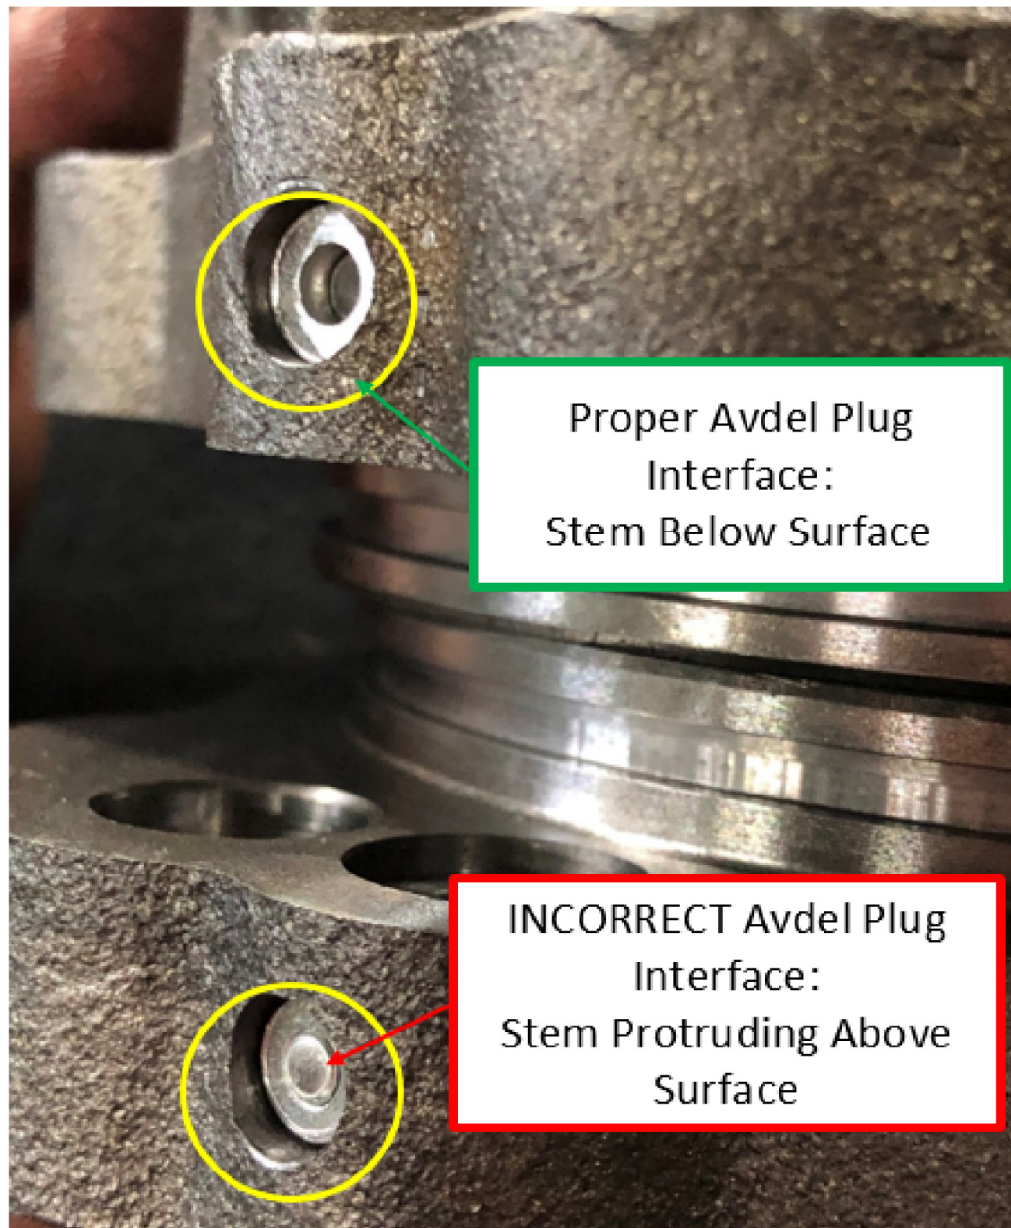
1. Inspect the sealing plug on the steering gear. The sealing plug is found on the input shaft end of the gear, against the frame in the location marked below.
 - A properly installed sealing plug will have the stem below the surface of the plug face.
 - An improperly installed plug will have the stem protruding from the face of the plug.

2. If the stem is protruding from the face of the plug, replace the steering gear.
