Technical Bulletin

00 18 08 November 21, 2018 **2053065**

Additional Safety Related Inquiry and Reporting

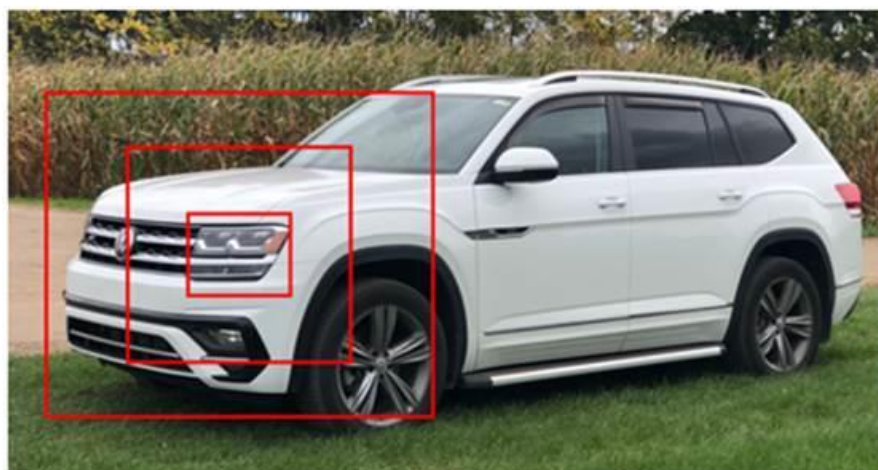
Figure 1: Attach pictures of the area, at several zoom levels, when applicable.

When documenting the damage include photos of the overall view of the damage (vehicle from all sides and close-ups of the damage or failed component) with front airbag deployment photos of cross member and side member (Figure 1).
