**IB19-E-001A**

**FTR FRONT END NOISE**

**AFFECTED VEHICLES**

- 2018-2020 MY Isuzu FTR vehicles produced prior to January 10, 2019

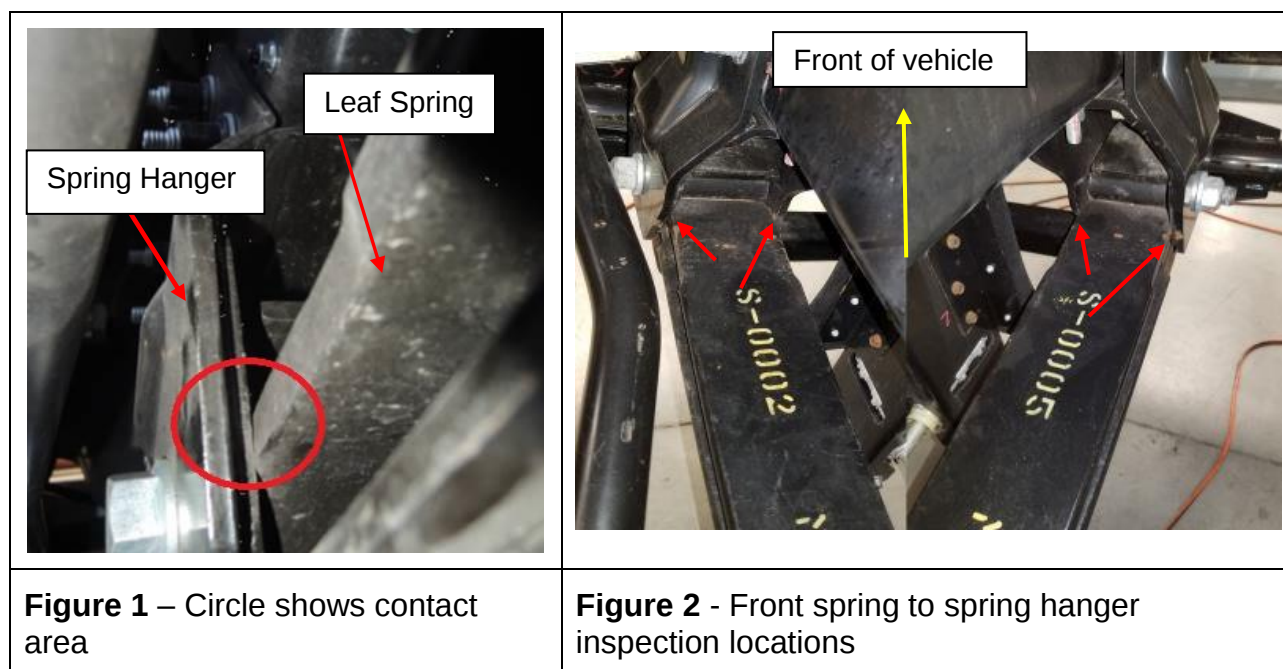
Some customers may complain about a clunking noise coming from the front end typically heard when turning into an uneven road surface or while turning and hitting a bump. This clunking noise may be caused by the front leaf spring contacting the spring hanger as shown in Figure 1.

Inspect the four locations at the front spring forward hanger, as shown with red arrows in Figure 2, for evidence of contact. If evidence of contact is present, replace both front leaf springs with updated leaf springs by following the procedure set forth in the applicable WSM. This will increase the clearance and prevent contact in the future. (See Table 1.)
