November 09, 2018

51G4 UPDATE - Seam Sealer Application (NVLW)

This update has been proactively released to apply seam sealer to prevent water from entering and wetting the driver and or passenger floor board area.

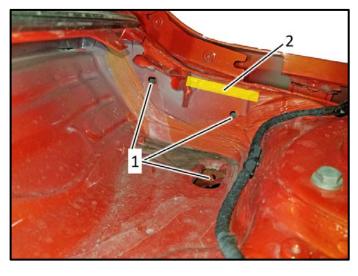
Apply seam sealer driver side.

Water leak due to improper application of body seam sealer.

- Use a gloved finger or a small brush to apply the seam sealer.
- Ensure area is dry.
- Completely cover holes <1> with sealer.

Do not cover the large plenum chamber drain.

Completely cover exposed seams in the shaded area <2>.
