Technical Bulletin

Model(s)	Year	Eng. Code	Trans. Code	VIN Range From	VIN Range To
Tiguan LWB	2018	All	All	All	All
Tiguan LWB	2019	All	All	AX_KM000001	AX_KM019515

92 18 02 November 6, 2018 **2052810**

Windshield Washer Fluid Leaking

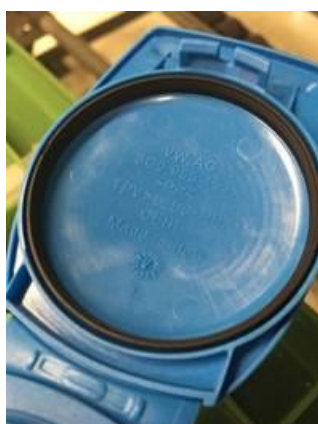
Figure 1 – New Washer Cap

Windshield washer fluid leaks through the reservoir cap due to slushing action while braking.

New windshield washer reservoir cap with seal implemented in production as of VIN: AX_KM019515.

Check if washer cap P/N: **3Q0-955-455** is installed and replaced it with P/N: **3G0-955-455**. See ETKA for the latest part supersession.
