Technical Bulletin

50 18 05 November 7, 2018 **2052766** Supersedes Technical Bulletin 50-18-04 (V501804) dated October 30, 2018 to include additional service procedures and update VIN range.

Water Leak - Driver or Passenger Floor Board

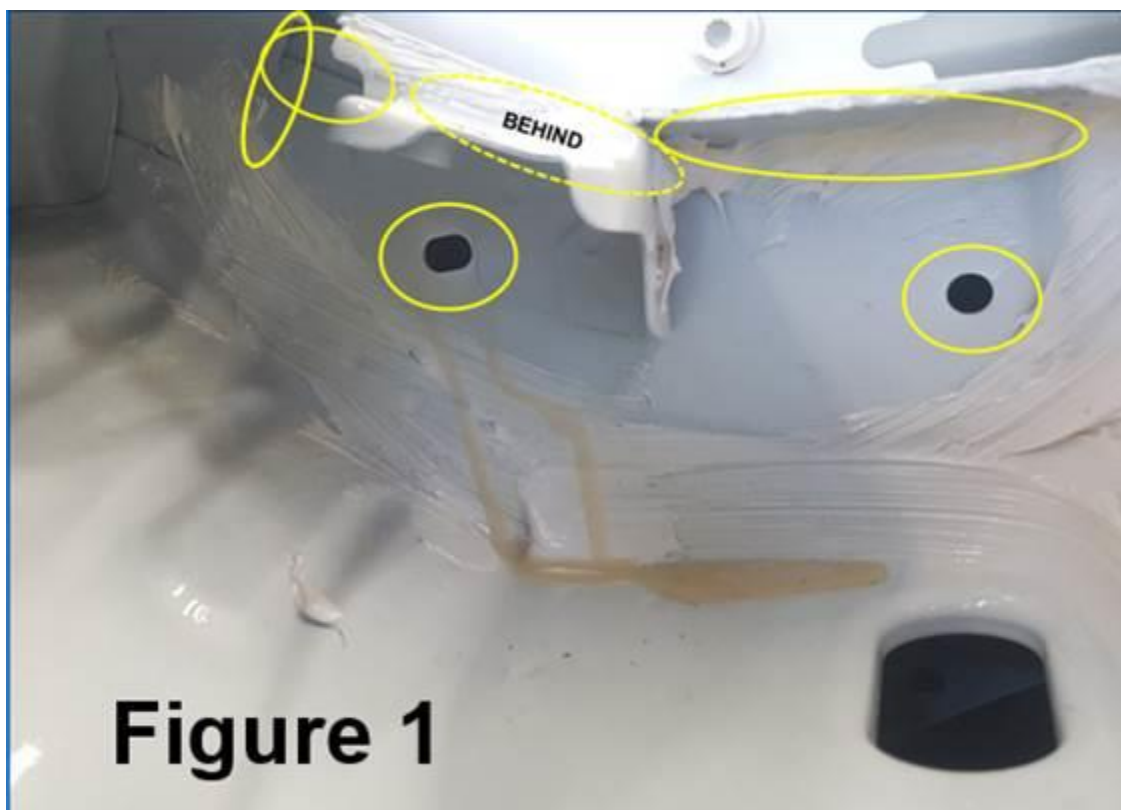
Water leak due to improper application of body seam sealer.

5.1 Apply seam sealer in the areas marked for the driver side (Figure 1).
