# FIELD SERVICE CAMPAIGN BULLETIN

Subject: **Field Service Campaign D19M5**  
**GHG17 Detroit DD5 Software Reprogramming for Thomas Built Bus Applications**

## **Field Service Campaign Bulletin D19M5**

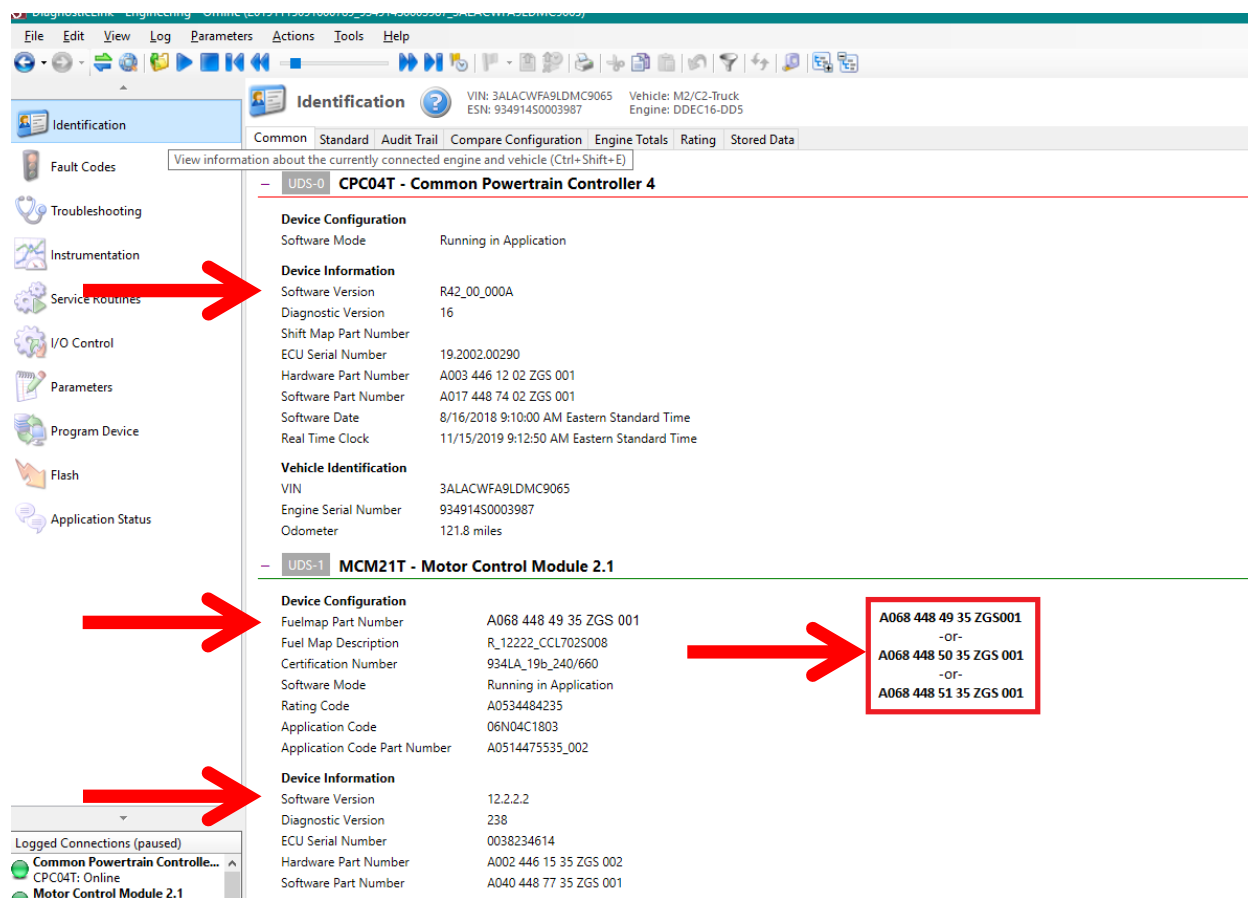
Figure 1 – DiagnosticLink® Identification Screen (CPC/MCM)

4. On the Identification screen, check the current MCM, ACM and CPC Software level. Listed below are the **MINIMUM** software levels and fuel map part numbers required. See Figure 1 for an example of the Identification screen.
  - a. MCM software **12.2.2.2** with fuel map part number:
    - i. 200 hp rating A0684484935 ZGS 001
    - ii. 220 hp rating A0684485035 ZGS 001
    - iii. 240 hp rating A0684485135 ZGS 001
  - b. ACM software **13.54.2.0** with fuel map part number A0194486654 ZGS 002
  - c. CPC software **R42 00 000A**
