FIELD SERVICE CAMPAIGN BULLETIN

Subject: **Field Service Campaign D19M6**
MDEG Air Compressor Upper Suction Line and Oil Fill Cap

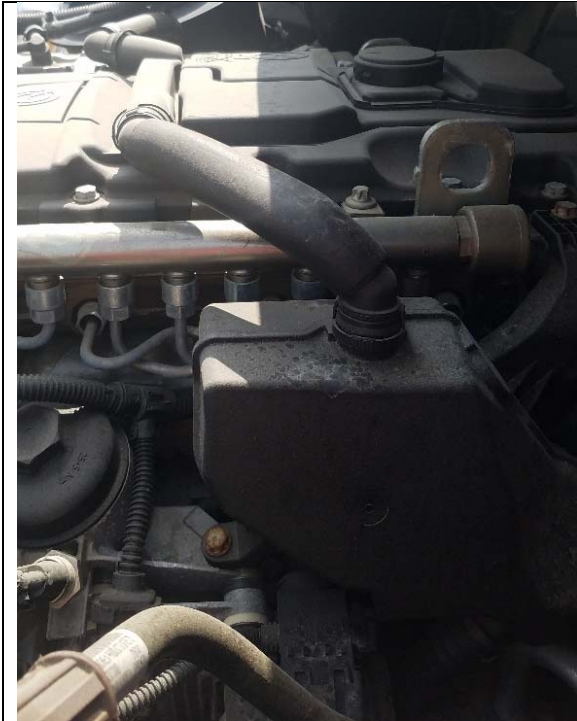
An improved air compressor upper suction line became available for service February 22, 2019. All model D934912(C) engines were manufactured with the previous air compressor upper suction line and require replacement with the new suction line. Units that previously had the upper suction line replaced may already have the improved upper suction line. These units will not require line replacement.

Original Air Compressor Upper Suction Line

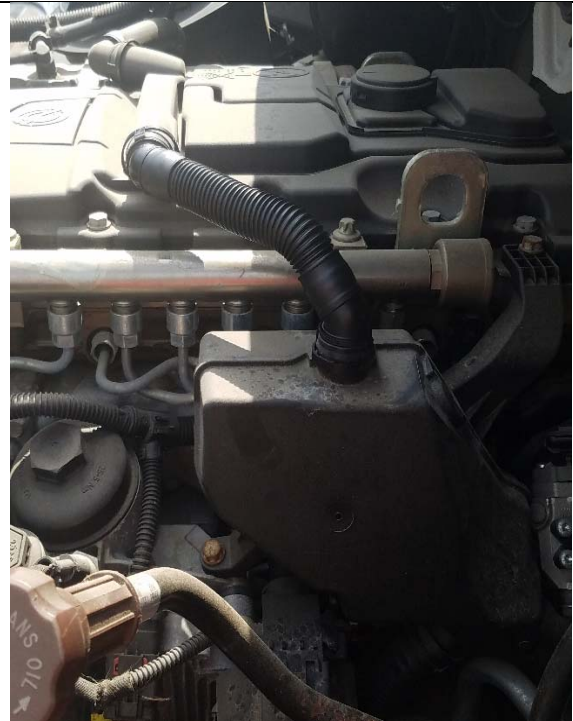
The improved air compressor upper suction line may reduce or prevent the air compressor from debris ingestion.

Improved Air Compressor Upper Suction Line P/N A9361306257

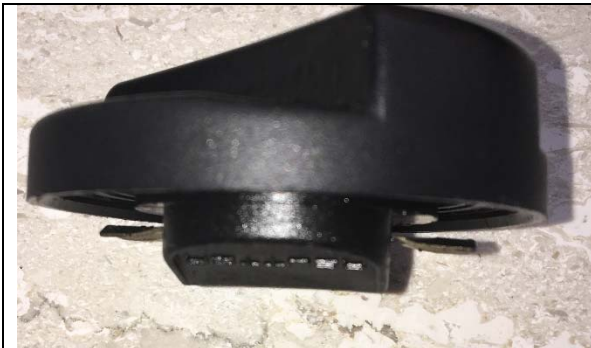
Improved oil fill caps became effective with engines manufactured after March 4, 2019. The improved oil fill cap reduces the chance of improper oil fill cap installation.

Original Oil Fill Cap

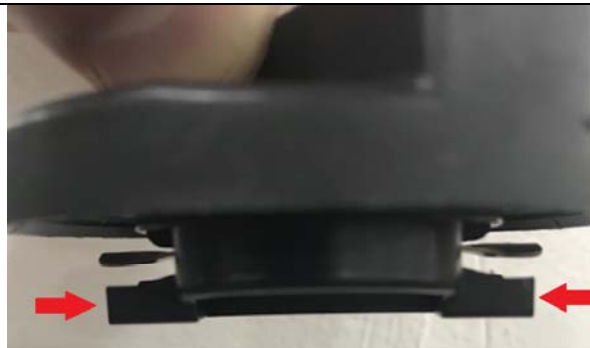
Improved Oil Fill Cap P/N A0000101485

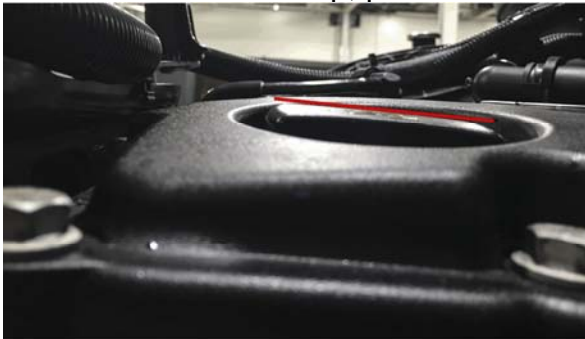
Figure 2 – Oil Fill Cap Correctly Latched

Note the angle of the cap and how the cap sits flush on the front and slightly lower on the back.

6. Connect the new updated upper suction line, part number A9361306257, to air compressor resonator.
7. Remove and save the oil fill cap from the rocker cover.
8. Install the new oil fill cap, part number A0000101485. See Figure 2.
