Technical Service Bulletin

57 Power closing door latch is intermittently inoperative

57 20 63 2058159/1 January 8, 2020.

Model(s)	Year	VIN Range	Vehicle-Specific Equipment
Q7	2017 - 2019	All	With Power Closing

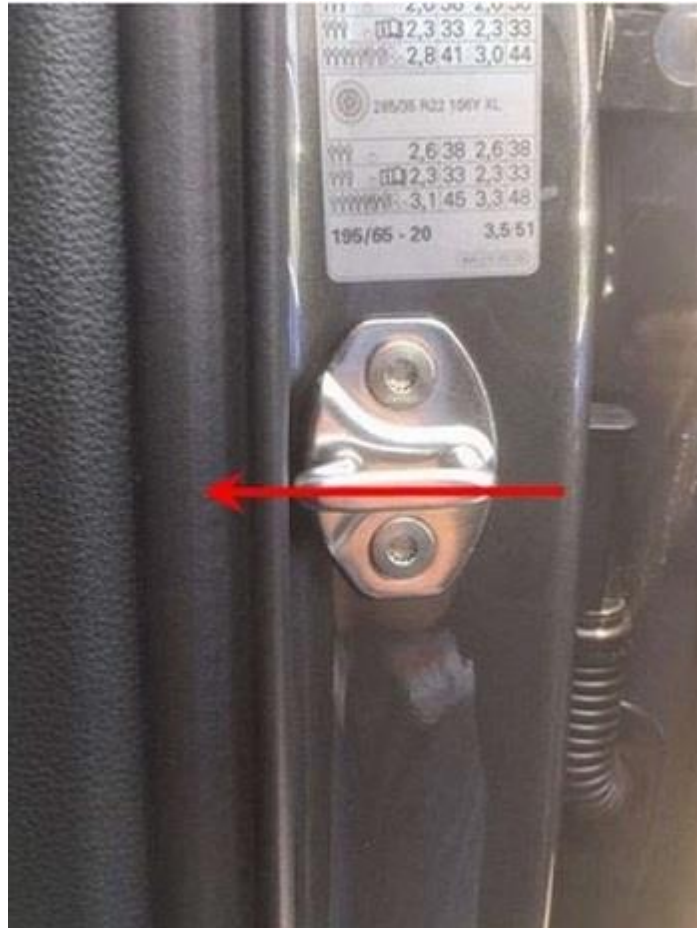
- The door striker stops in the pre latch position and the door is not closed via the power closing door system.

The door latch requires counter-pressure from the door/door seal, in order to generate a reliable signal for the door control module that the customer wants to close the door. If the door striker is adjusted in such a way that does not provide enough counter-pressure for the latch, the door control module does not recognize the door latch signal long enough or at all. Hence the door will not be closed.

Figure 1. Adjust door striker inward by at least 0.5 mm.

2. At the same time, adjust the door striker inward as far as possible (at least 0.5 mm) (Figure 1). The front door can be flush or slightly underflush to the rear door without causing a wind noise concern (Figure 2).

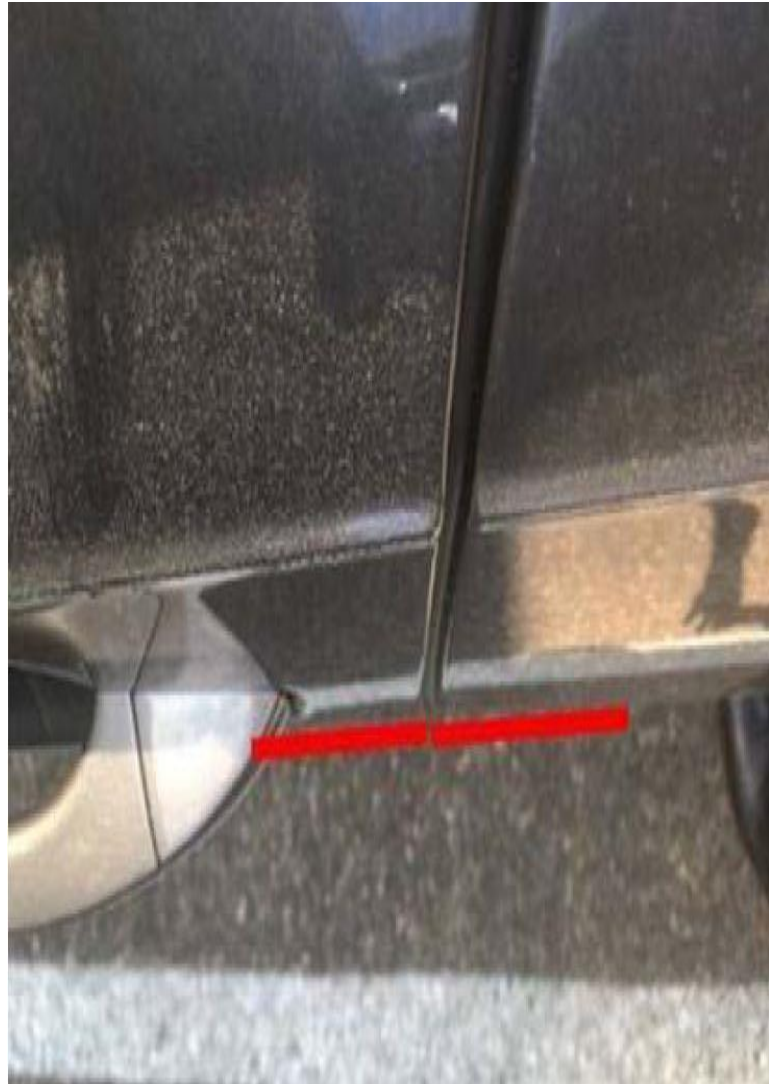
Figure 2. The front door can be flush or slightly underflush to the rear door.

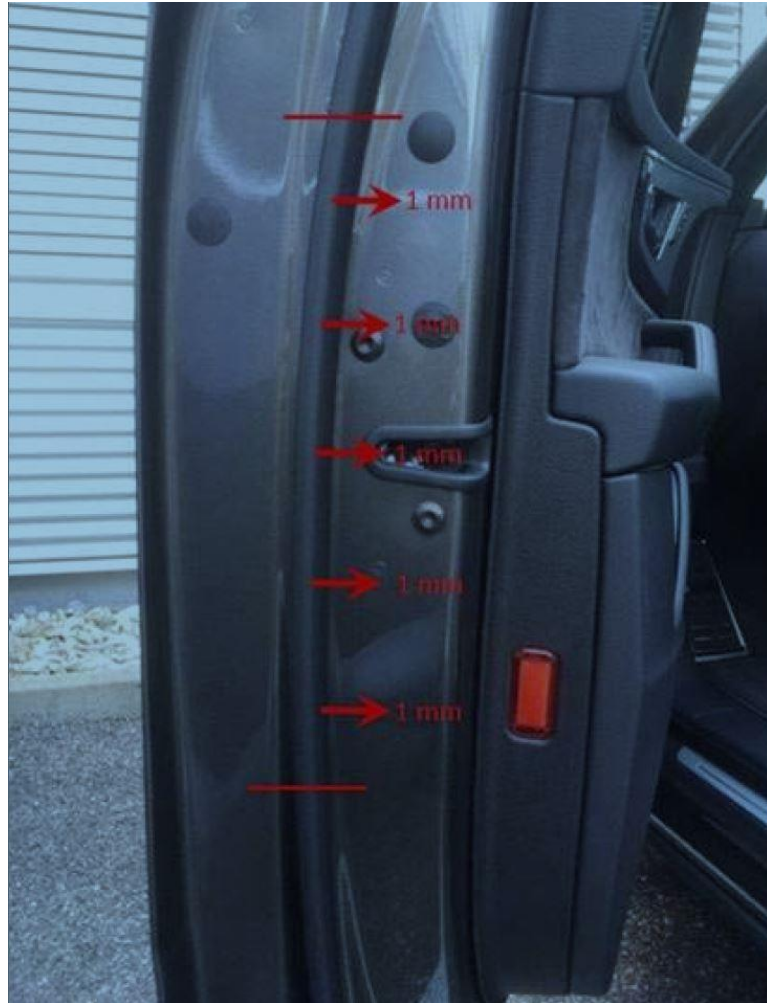
Figure 3. Install the new outer door seal with an inward offset by 1.0 mm.

4. If the customer concern still persists, install a new outer door seal with an inward offset of 1.0 mm when compared to the original door seal location (Figure 3).

**Tip:** Mark the position of the original outer door seal prior to replacing it.
