Technical Service Bulletin

91 MIB2 High: Navigation initialization stuck at 77%

91 20 27 2058160/2 January 8, 2020. Supersedes Technical Service Bulletin Group 91 number 19-24 dated December 20, 2019 for reasons listed below.

Model(s)	Year	VIN Range	Vehicle-Specific Equipment
A6, A7	2015 - 2016	All	MIB2 High

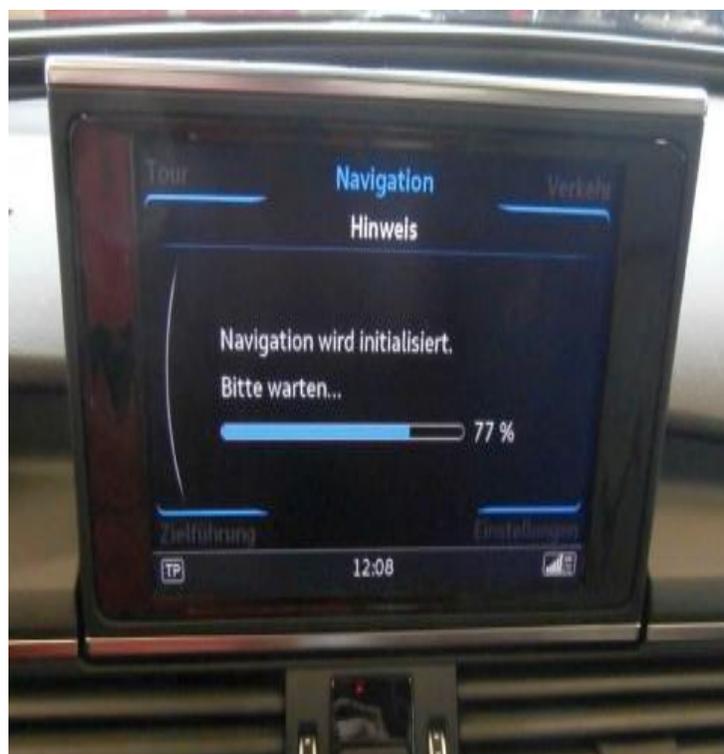
- The navigation system initializes up to 77% and freezes there (Figure 1).

Figure 1. Navigation system is frozen at 77%.

A software bug causes the initialization to freeze.

1. Follow all instructions in TSB 2047576: *91 MIB2 High Software Update Instructions (PR Code 7UG)*.
2. Update the Infotainment System using the SVM action code as listed in the table below, if necessary:

Both updates (Steps 1 and 2 in the update table) have to be performed in sequential order. Mixing up the update order can render the main unit inoperable.
