Technical Service Bulletin

| Subject: CREAKING NOISE FROM FRONT LOWER ARM BUSHING / CLUNKING NOISE FROM FRONT SHOCK ABSORBER COIL SPRING WHEN DRIVING OVER BUMPS | Bulletin No.: 02-001/20 |
| | Last Issued: 01/09/2020 |

2016-2020 CX-9

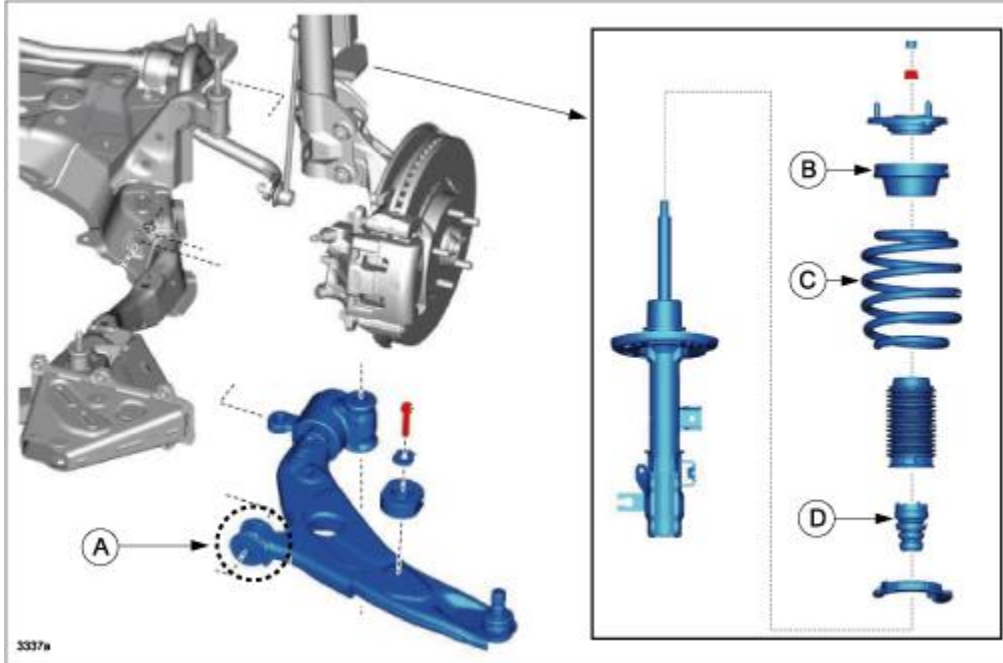
Some vehicles may exhibit one or more of the following noises from the front suspension:

1. A creaking noise from under the front of the vehicle (front lower arm bushing) when driving over bumps at approximate 12 - 25 mph (20 - 40 Km/h). The noise occurs when the road surface is wet or after the vehicle has been washed. The noise becomes more noticeable as the bumps get higher. The creaking noise is caused by the front lower arm bushing (A) making a stick-slip noise during wet road conditions.
2. A clunking noise from the front coil spring when driving over bumps. The clunking noise is due to stick-slip between the front strut bearing (B) and the coil spring (C).
3. A popping noise from the bump stopper (D) when driving through gutters.

To eliminate the noise, the following mass-production changes have been made:

1. The coating treatment of the lower arm bushing has been changed to reduce friction and prevent stick-slip.
2. Protectors have been installed onto the coil springs to prevent stick-slip.
3. **The bump stopper has been modified and grease application has been added to prevent the stick-slip.**
