Subject: SCRATCH ON SEAT BACK BAR GARNISH FROM CONTACT WITH CONVERTIBLE TOP	Bulletin No.: 09-001/20
	Last Issued: 01/07/2020

2016-2020 MX-5

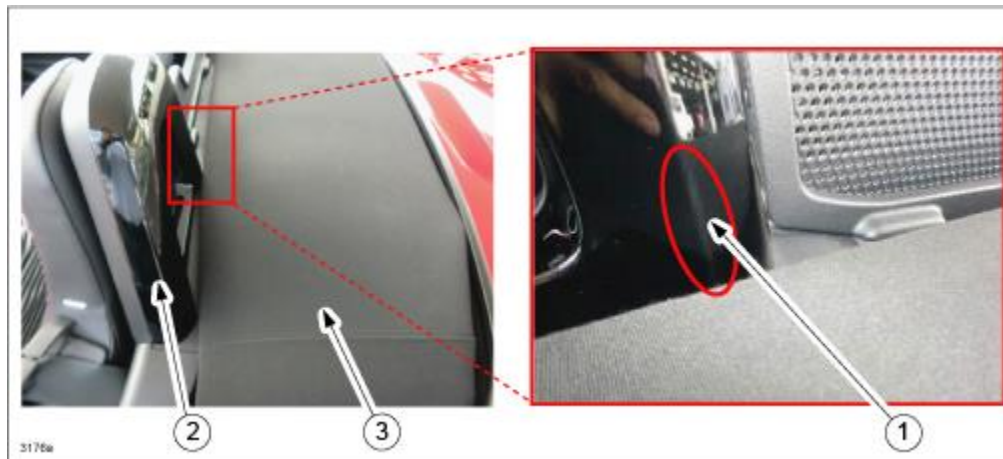
Some vehicles may exhibit scratches (1) on the rear of the seat back bar garnish (2) from contact with the convertible top (3).

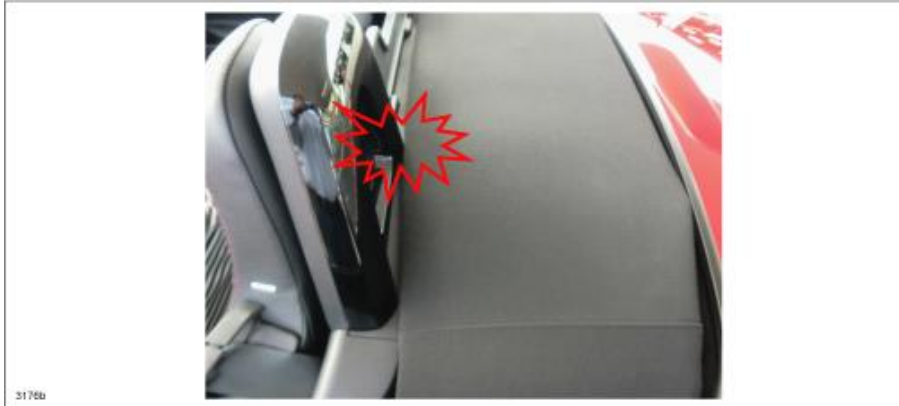
Due to assembly variations, the clearance between the seat back bar garnish and the convertible top is too small on some vehicles.

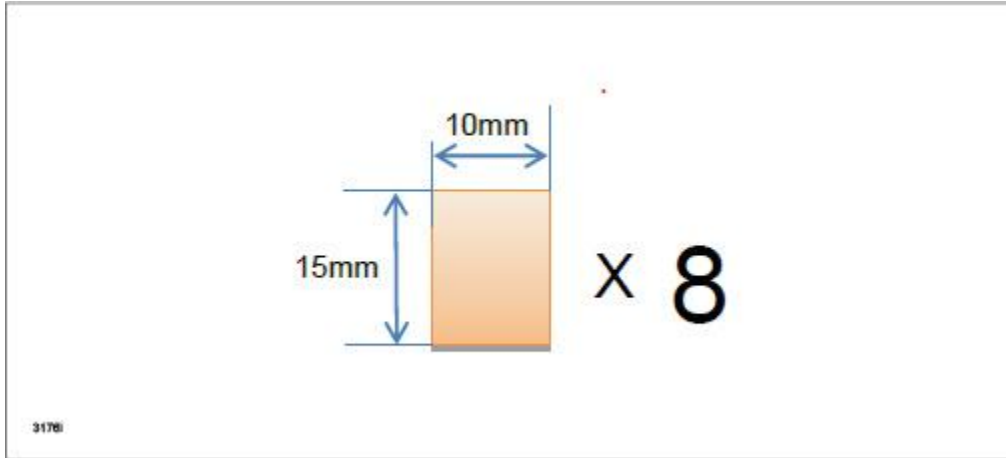
NOTE: The holes may be damaged when removing the metal fasteners of the back trim from the square holes of the seat back crossmember. A loose fit of these fasteners could cause a creak noise.

a. Select a 0.25 mm thickness fabric sheet from the “Noise Repair Kit” (TA01-76-100) and cut out 8 equal squares 15mm x 10mm.
