Technical Service Bulletin

Subject: RUST AROUND REAR VIEW CAMERA AND/OR LIFTGATE OPENER SWITCH	Bulletin No.: 09-004/20
	Last Issued: 01/10/2020

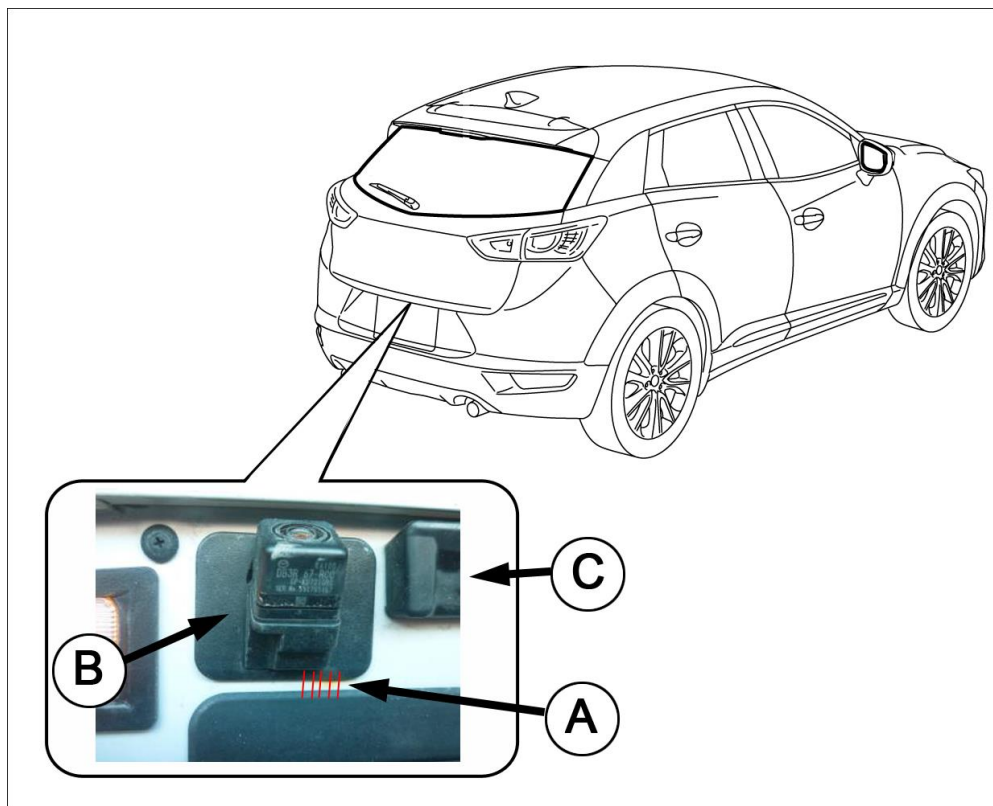
Some vehicles may exhibit rust (A) on the liftgate around the border of the rear mount camera (B) and/or the liftgate opener switch (C). Repair the paint rust and install a pad to prevent future paint rust.

1. Verify customer concern.
2. Repair the affected area of the liftgate by ordinary paint rust damage repair procedure.

NOTE: Repair affected area(s) only. There is no need to repaint the whole liftgate.

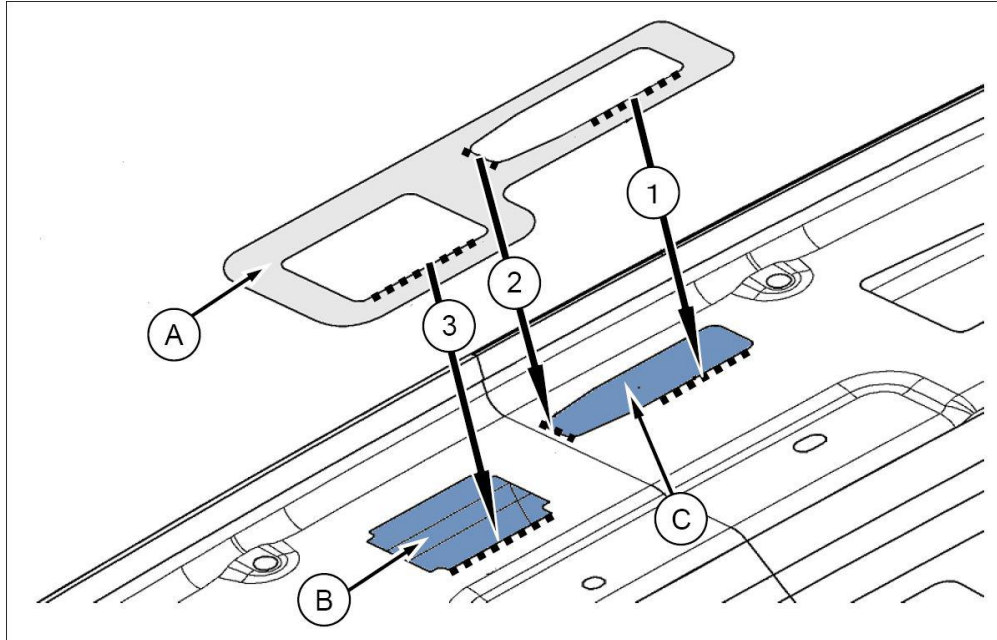
A	Protector Film
B	Installation Hole for Rear Mount Camera
C	Installation Hole for Liftgate Opener Switch

3. To prevent direct interference of the rear mount camera and liftgate opener switch mount bases with the liftgate paint surface, attach a protector film (DBY0-62-864) to the liftgate.

- Degrease the liftgate where the protector film is attached.
- The protector film (A) must not cover the installation holes for the rear mount camera (B) and liftgate opener switch (C). To attach the protector film in the correct position, first align three edges (marked with 1 - 3 in figure) of the protector film with three edges (marked with 1 - 3 in figure) of the installation holes, and then attach the whole protector film without leaving air bubbles.
