GROUP <b>Product Improvement</b>	MODEL <b>See Model List on Page 1</b>
	NUMBER <b>PI1802W/X (Rev 7, 01/15/2020)</b>	DATE <b>October 2018</b>
<b>PRODUCT IMPROVEMENT CAMPAIGN</b>		
SUBJECT: <b>ENGINE REPLACEMENT INSTRUCTIONS FOR DTC P1326 (PI1802W/X)</b>

This bulletin provides information related to the Technical Service Bulletin previously published in July 2018 ([PI1802](#), Rev 6, 01/31/2019) titled “Knock Sensor Detection System - ECU Logic Improvement”. Specifically, this bulletin provides instructions on which procedures to follow if, after installation of the KSDS, any one of the subject vehicles below returns to the dealer with Diagnostic Trouble Code (“DTC”), P1326.

Year	Model	Engine	Production Date
2014	Optima (TF)	2.4L GDI	8/29/13 – 4/25/14
2015-2018	Optima (TF/QF/JF/JFa)	2.4L & 2.0L T-GDI	4/16/14 – 7/11/18
2014-2018	Sportage (SL/QL)	2.4L & 2.0L T-GDI	9/30/13 – 4/5/18
2015-2018	Sorento (XMa/UMa)	2.4L & 2.0L T-GDI	1/3/14 – 3/7/18

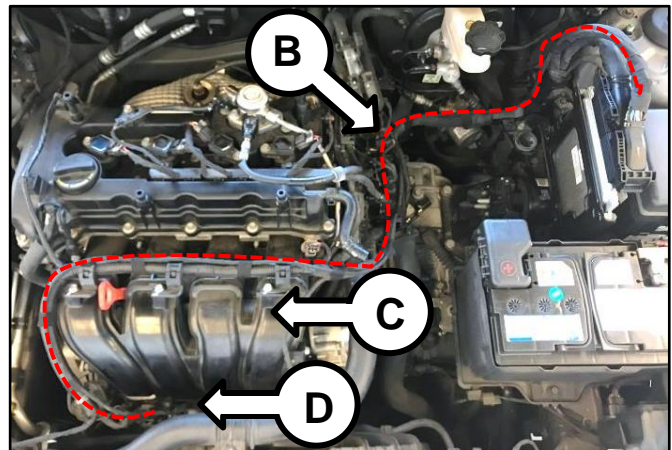
The harness (B) must be routed exactly as shown to prevent related DTCs.

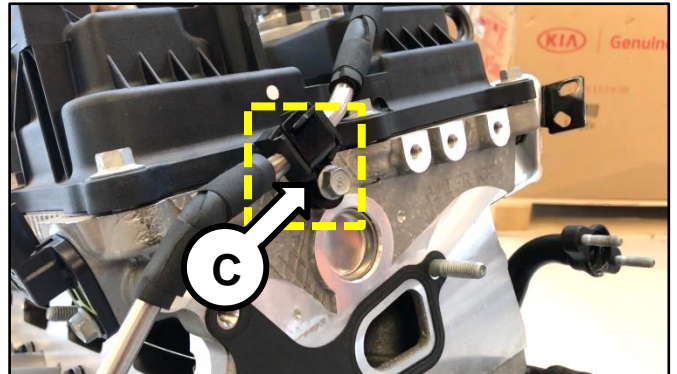
If the bracket and bolt are missing, order and install a new bracket and bolt.

**Tightening torque (bracket bolt):**  
 5.8 – 8.7 lb.ft (7.8 – 11.8 N.m,  
 0.8 – 1.2 kgf.m)
