GROUP BOD	MODEL 2020MY Soul (SK3)
	NUMBER 203	DATE January 2020
TECHNICAL SERVICE BULLETIN		
SUBJECT: SERVICE ACTION: RETIGHTENING WIPER ARM NUTS (SA412)

SERVICE ACTION: RETIGHTENING WIPER ARM NUTS (SA412)

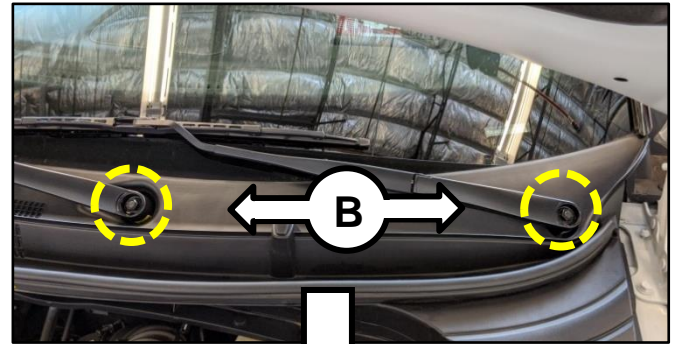
This bulletin provides the procedure to retighten the wiper arm nuts to the torque specification on some 2020MY Soul (SK3) vehicles produced from November 4, 2019 through December 12, 2019, which may not have been properly torqued during assembly. Before conducting the procedure, verify the vehicle is included in the list of affected VINs.

3. Tighten the two (2) left and right wiper arm retaining bolts (B) to specifications.

Torque specification for nut(s) (B):
16.6 – 19.5 lb.ft (22.6 – 26.5 N.m,
2.3 – 2.7 kgf.m)
