Service Alert

Subject: INSTRUMENT CLUSTER WARNING MESSAGE "SAFETY AND DRIVER SUPPORT SYSTEMS PARTIALLY DISABLED" AND DTC U0401:68 IS STORED	Service Alert No.: SA-008/20
	Last Issued: 01/10/2020

APPLICABLE MODEL(S)/VINS
2019 Mazda3

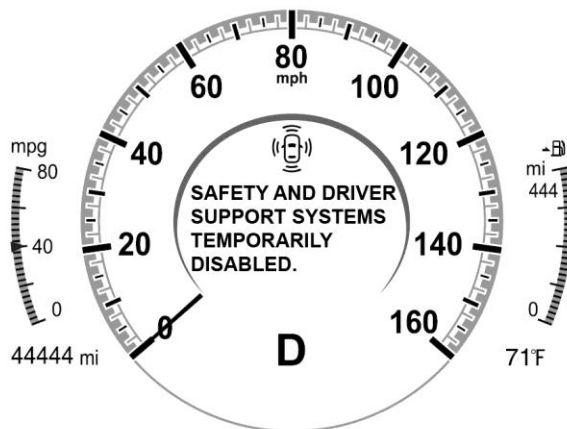
Some customers may experience an instrument cluster warning message "Safety and Driver Support Systems Partially Disabled" and DTC U0401:68 [VEHICLE CONTROL MODULE (US)] (Error signal received from PCM, DSC HU/CM, instrument cluster, or body control module (BCM)) stored. This may be caused by the customer riding the brake pedal.

1. Verify customer concern.
2. Perform MDARS VCM software update.
3. Erase any DTC's if stored.
4. Verify repair.
