## Cougar West Coast Inverter Prep

**Models Included:** 2020 Cougar: 22RBSWE, 29RLKWE, 31BHKWE

**Serial Number Range:** LC503030 - LC504734

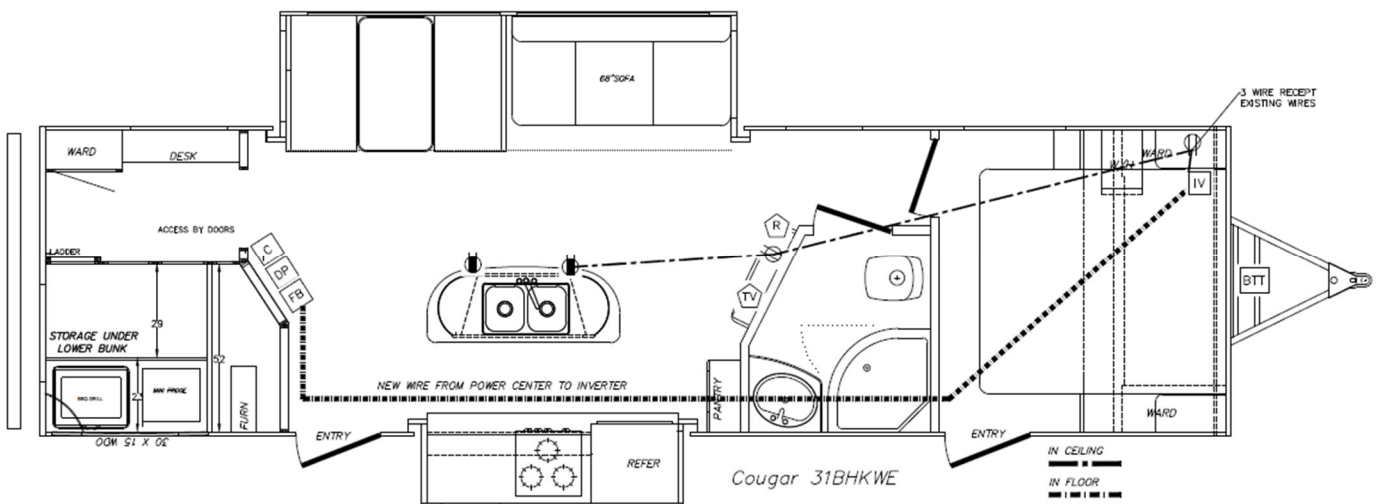
Originally the kitchen base GFCI receptacle was wired to the load center. Now that wire is removed and cut back so that it cannot be used again. This will make the kitchen base GFCI receptacle a two wire receptacle and it is connected to the front bedroom receptacle and the TV receptacle. The front bedroom receptacle will now become a two wire receptacle and is wired to the inverter and the kitchen base GFCI.
