HYUNDAI Technical Service Bulletin

NUMBER
20-BE-002H

MODEL(S)
PALISADE (LX2)

SUBJECT: BLIND-SPOT COLLISION WARNING (BCW) RADAR UPDATE

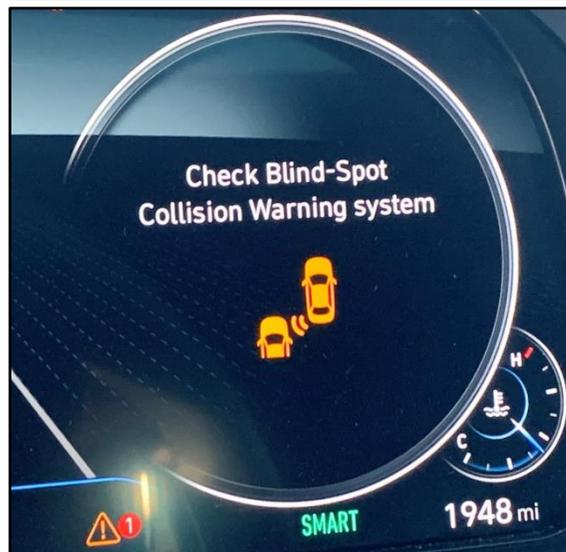
Description: Some Palisade (LX2) vehicles may intermittently experience the BCW Malfunction Indicator Light ON with a message “Check Blind-Spot Collision Warning System” displayed on the instrument cluster. When the BCW Malfunction Indicator Light is ON, the BCW function becomes inoperative. This bulletin provides the service procedure to update the BCW system software to correct the intermittent BCW Malfunction Indicator Light.

NOTE: When the BCW Malfunction Indicator Message turns ON, the diagnostic code C270354 (Control Module Slave Calibration) will be triggered.

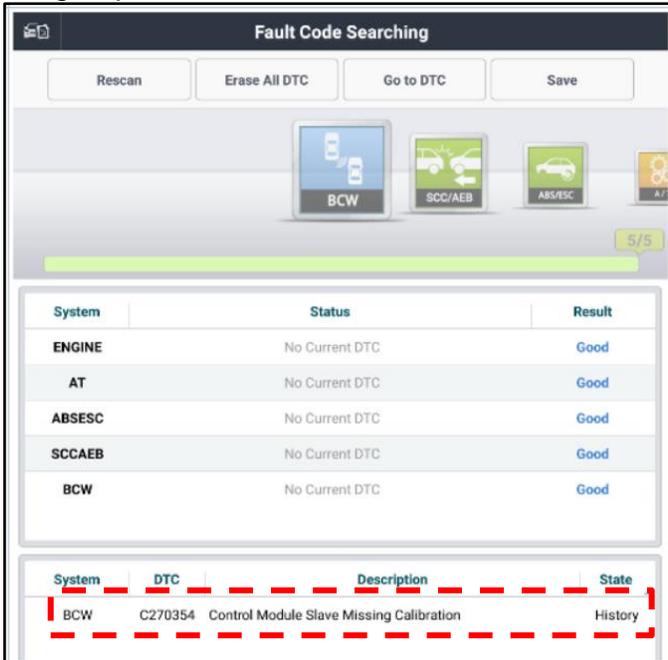
2. Take a picture or screenshot of the GDS displaying DTC C270354 in history for warranty claim image upload.
