MODEL
2019MY
Niro (DE EV)

NUMBER
197

TECHNICAL SERVICE BULLETIN

SUBJECT: SNOW ACCUMULATION OR FREEZING
COUNTERMEASURE FOR EV CHARGING DOOR

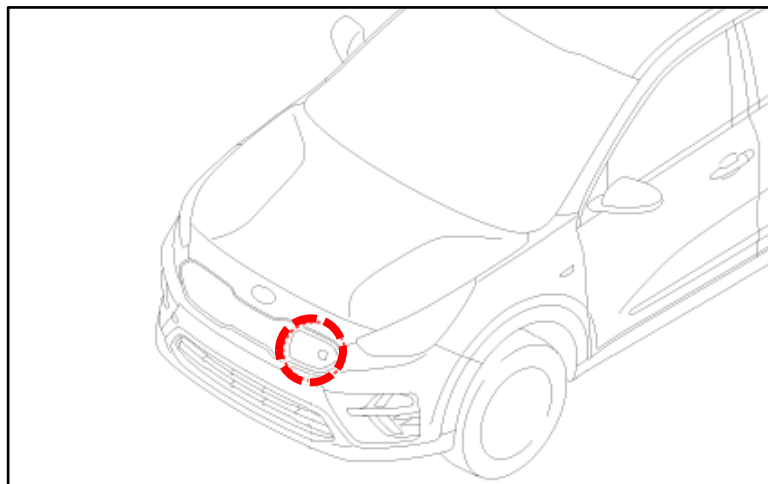
Charge Door location on 19MY Niro (DE EV)

This bulletin provides information on the installation of charge door spacing pads on some 2019MY Niro (DE EV) vehicles which may exhibit snow accumulation or freezing when driving in snow conditions. Snow accumulation or freezing on the charging door is reduced by installing two (2) 4mm Thermoplastic Elastomer (TPE) spacer pads to inside of the charge door in order to enable snow to be released.
