MODEL  
2020MY  
Soul (SK3)

NUMBER  
101

## TECHNICAL SERVICE BULLETIN

SUBJECT: CREAKING OR POPPING NOISE  
FROM STEERING WHEEL COLUMN TILT LEVER

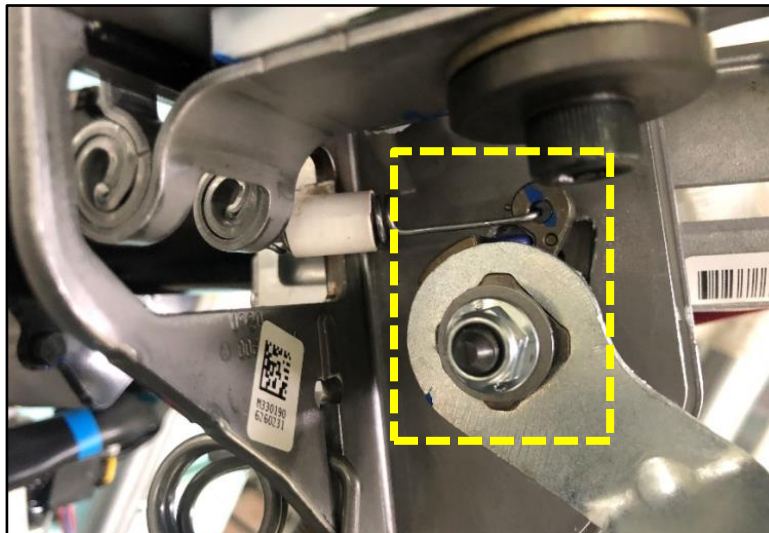
Steering column (creaking/popping) noise when turning.

This bulletin provides the procedure to repair a creaking/popping noise from the steering column area on some 2020MY Soul (SK3) vehicles, which may be heard when turning the steering wheel at low speeds or while stopped. To repair this concern, follow the procedure outlined in this bulletin to replace and install the improved fixed cam kit to the steering column.
