# Technical product information

<b>Topic</b>	Continental GTC - Hood insulation pad tension strap fitting procedure
<b>Market area</b>	Bentley: worldwide (2WBE)
<b>Brand</b>	Bentley
<b>Transaction No.</b>	2058277/1
<b>Level</b>	EH
<b>Status</b>	Approval
<b>Release date</b>

## Continental GTC

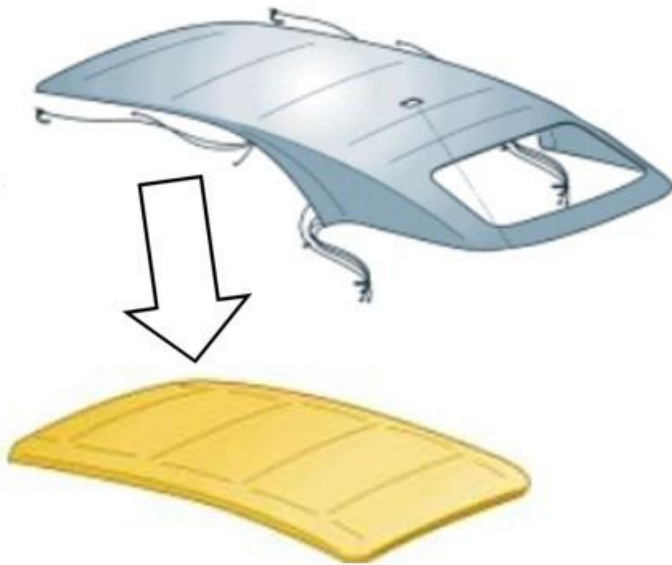
Figure 1

In the event the insulation pad (ARROW - Figure 1) requires replacing, the onward instructions within this TPI must be followed

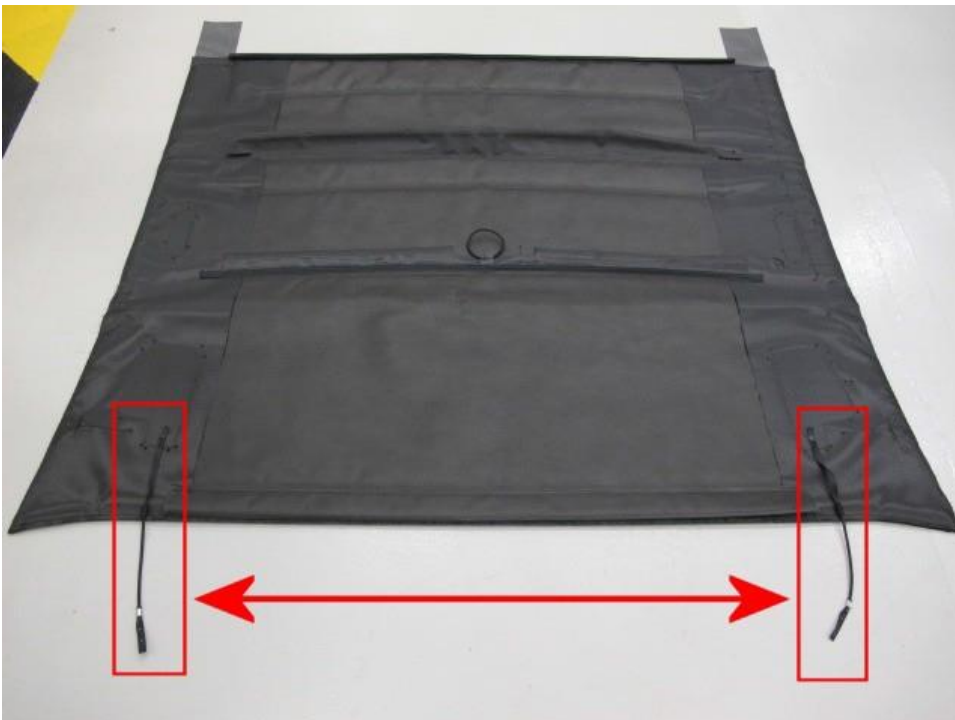
Figure 2

The right and left hand tension straps (Figure 2) are no longer fitted at the time of manufacture, the Measure section within this TPI details the procedure which must be followed to fit the tension straps
