**FIELD SERVICE CAMPAIGN – 19116**

15 January 2020

Remote Power Module Data Link Circuit

International® HV™ Series

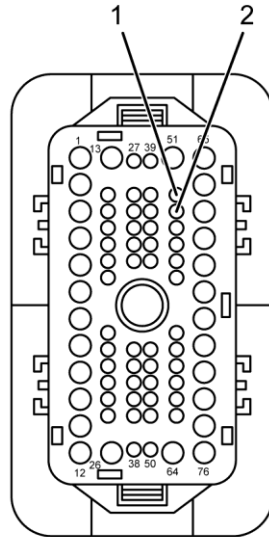
**Figure 2. 1701F Connector Face View**

1. Cavity 52
2. Cavity 53

8. Ensure that the 18 AWG YELLOW wire (ZE5E+) is inserted into cavity 52 (Figure 2, Item 1).
9. Ensure that the 18 AWG GREEN wire (ZE5E-) is inserted into cavity 53 (Figure 2, Item 2).

10. Are wires in the correct cavities?
  - a. If wires are are in the wrong cavities, de-pin and reposition per Steps 8 and 9.
  - b. If wires are in the correct cavities, proceed to Step 11.

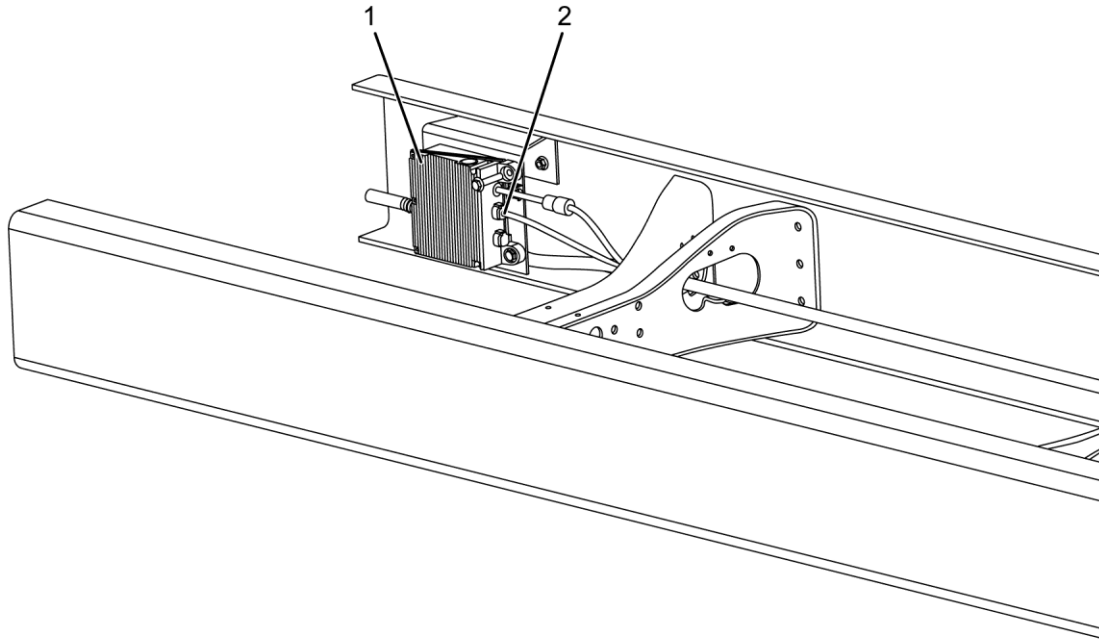
**Figure 3. Frame Rails at Rear of Chassis**

- 1. RPM module
- 2. 4410F harness connector

11. Locate the RPM module (Figure 3, Item 1) on the driver-side frame rail, at rear of the the chassis.
12. Disconnect the 4410F (6-pin) harness connector (Figure 3, Item 2) at the RPM module.

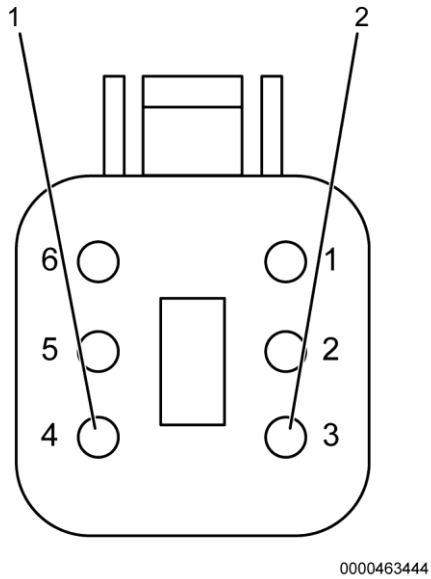
**Figure 4. 4410F Connector Face View**

1. Cavity 4
2. Cavity 3

13. Ensure that the 18 AWG YELLOW wire (ZE5E+) is inserted into cavity 3 (Figure 4, Item 2).
14. Ensure that the 18 AWG GREEN wire (ZE5E-) is inserted into cavity 4 (Figure 4, Item 1).

15. Are wires in the correct cavities?
  - a. If wires are in the wrong cavities, de-pin and reposition per Steps 13 and 14.
  - b. If wires are in the correct cavities, proceed to Step 16.
16. With a multimeter, perform continuity check between connector 1701F pin 52 and connector 4410F pin 3.
17. Repeat Step 14 for connector 1701F pin 53 and connector 4410F pin 4.
18. If continuity is not found between the appropriate cruits, repeat Steps 6 - 16 to verify that the circuit pins are in the correct cavities.
