**WKF2 - Replacing Pulse Sender (Workshop Campaign)**

Vehicle Type: **911 (992)**

Model Year: **2020**

Subject: **Pulse sender**

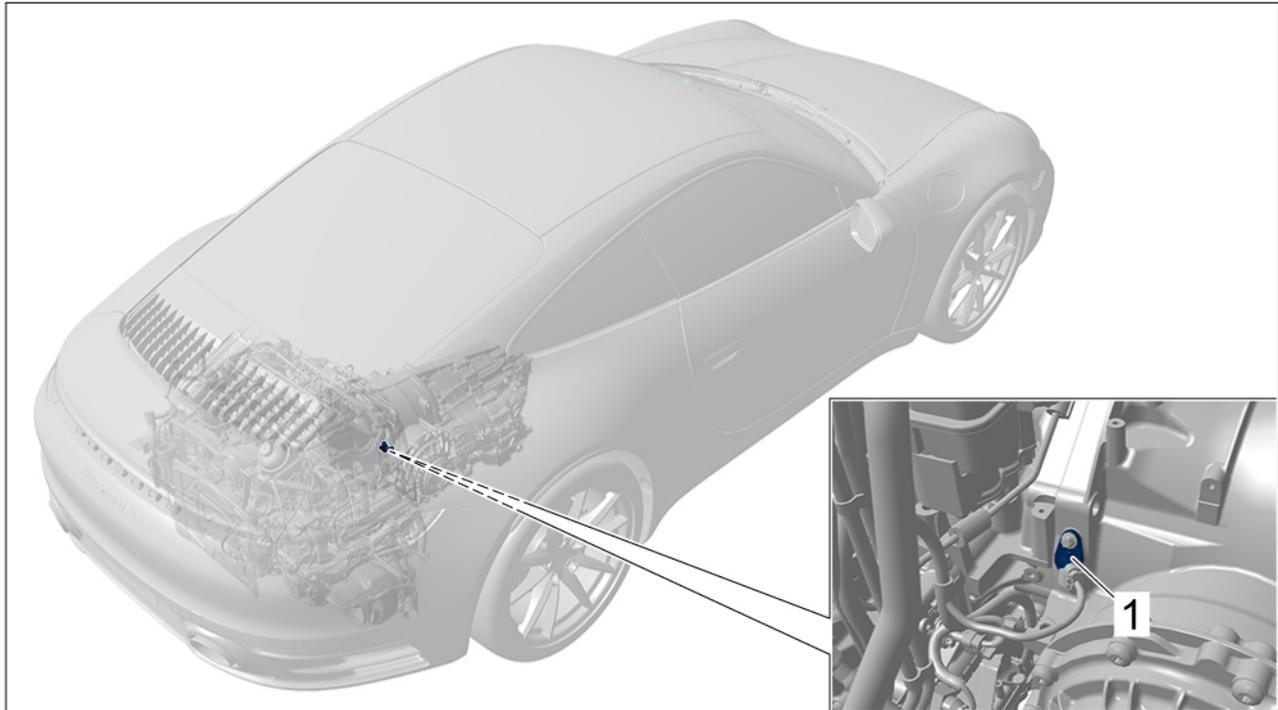
Information: **Due to a manufacturing problem with the pulse sender for the crankshaft, there is a possibility that the engine will be difficult to start and as a result, engine power will be reduced on the affected vehicles.**

*Installation position of pulse sender***1** – Pulse sender (replace)**Parts required****NOTICE****Using a pulse sender that has not been adequately tested**

Remedial Action: Replace pulse sender.

- Measure is ineffective
  - Engine control fault even after replacing the affected component
- ⇒ Check the marking on the new pulse sender before installing it.
- ⇒ Only pulse senders marked with a blue dot may be installed.
- ⇒ Pulse senders with a white dot or with no marking have not been adequately tested and must not be used.
