68/19 ENU

Complaint - Coolant Pipe at Front of Cylinder Head Leaking: Installing Coolant Pipe With Toothed Ring (68/19)

Cayenne (9YA) Vehicle Type:

Equipment: 3.0-liter 6-cylinder petrol engine (engine code: DCBE)

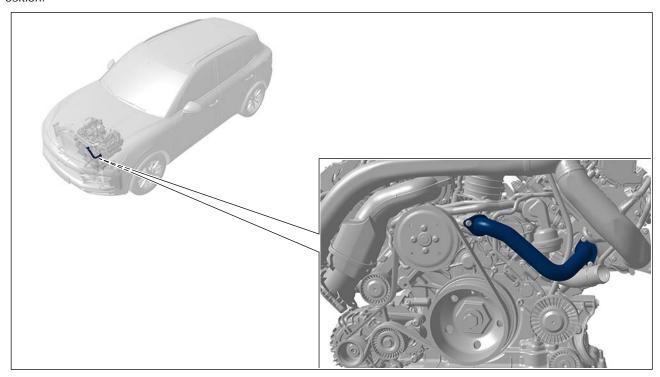
Coolant pipe at front of cylinder head

Coolant pipe in cylinder head flange area leaking Information:

On vehicles with high mileage, the coolant pipe (Part No. 9A712148101) in the cylinder head flange area can start to leak \Rightarrow Leak.

In the event of a complaint, replace coolant pipe on cylinder head with a modified coolant pipe with

toothed ring (Part No. PAC121507).
