Technical product information

Topic	Front roof console replacement - Continental Flying Spur
Market area	Bentley: worldwide (2WBE)
Brand	Bentley
Transaction No.	2058349/1
Level	EH
Status	Approval
Release date

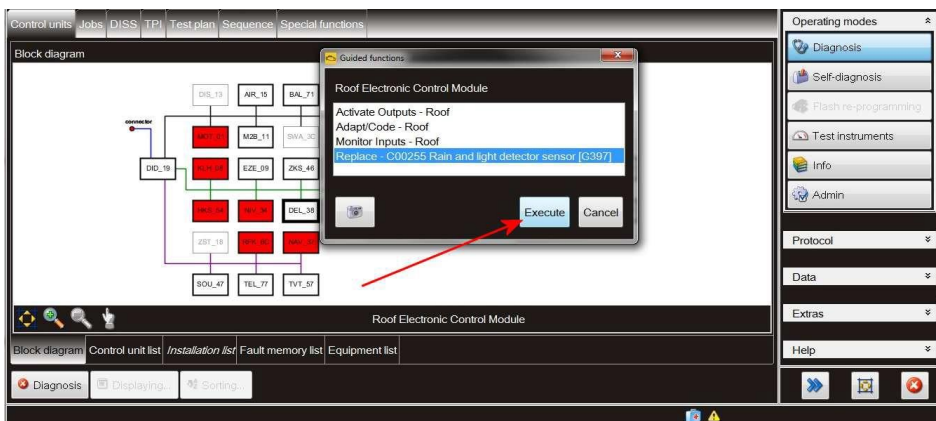
Front roof control module with the part numbers listed below are no longer programmed by Bentley Motors prior to dispatch

- Referring to Figure 1 - Navigate to the Roof Electronic control module
- Select Guided functions
- Select - Replace - C00255 Rain and light detector sensor (G397)
- Select - Execute and follow all remaining on screen prompts until the programming is complete
