Symptom - Body Exterior - Diagnostic Key Client Error Message "No Information Available": Re-coding Rear-end Electronics Control Unit (SY 135/19)

Vehicle Types: **Panamera (971)/Panamera 4 (971)/Panamera 4 E-Hybrid (971)/Panamera 4S (971)/Panamera GTS (971)/Panamera Turbo (971)/Panamera Turbo S E-Hybrid (971)**

Model Year: **As of 2017 up to 2019**

Subject: **Control unit for rear-end electronics**

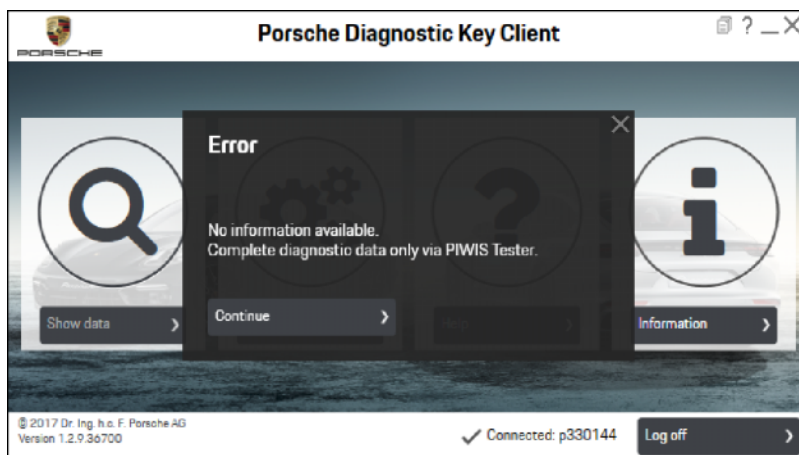
Symptom: When reading out the Porsche Diagnostic Key in the Diagnostic Key Client, the error message "No information available. Complete diagnostic information only available using the PIWIS Tester" appears.

Porsche Diagnostic Key Client error message

Cause: Due to a software error, the diagnostic data is not written to the driver's key (Diagnostic Key) on the affected vehicles.

Remedial action: If this problem occurs, the rear-end electronics control unit must be re-coded.
