DATE: 1-6-20

APPLIES TO: This service bulletin applies certain 2018, 2019, and 2020 model year K2, K3 and K4 model motorhome chassis, equipped with a keyless system supplied by Trimark, that were built between October 18, 2017 and July 25, 2019

CONDITION: No start exhibited when PKS is not authenticating.

CORRECTION: Replacement of Trimark Module

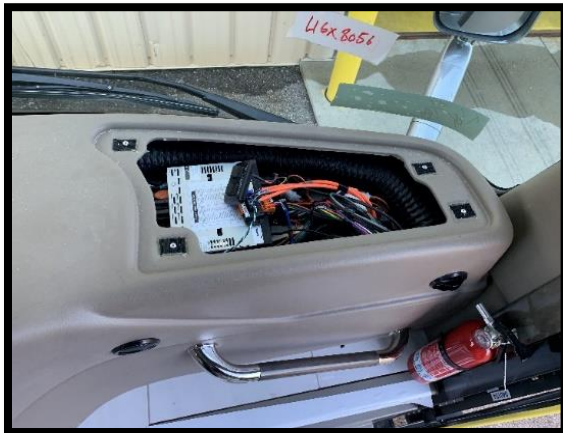
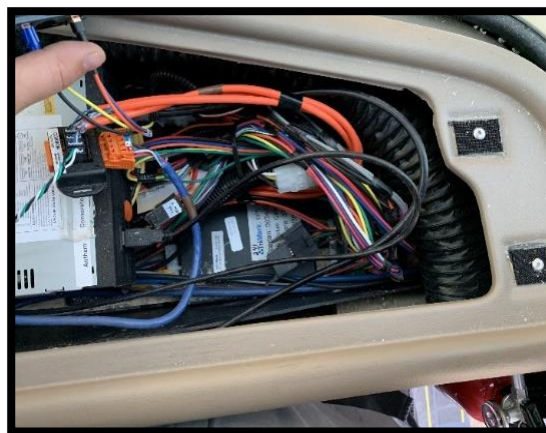
FIG. 2-1

Note: Items depicted in pictures are for reference only and are showing an Entegra location. The Trimark Module is located under the Velcro attached dash cover forward of entry step.

1. To locate the module, you will need to remove a Velcro attached panel. The module will be located as indicated below specific to OEM photos. Refer to FIG. 2-1. For further info Contact Spartan Customer & Product Support 1-855-589-9836 for placement of Trimark module.

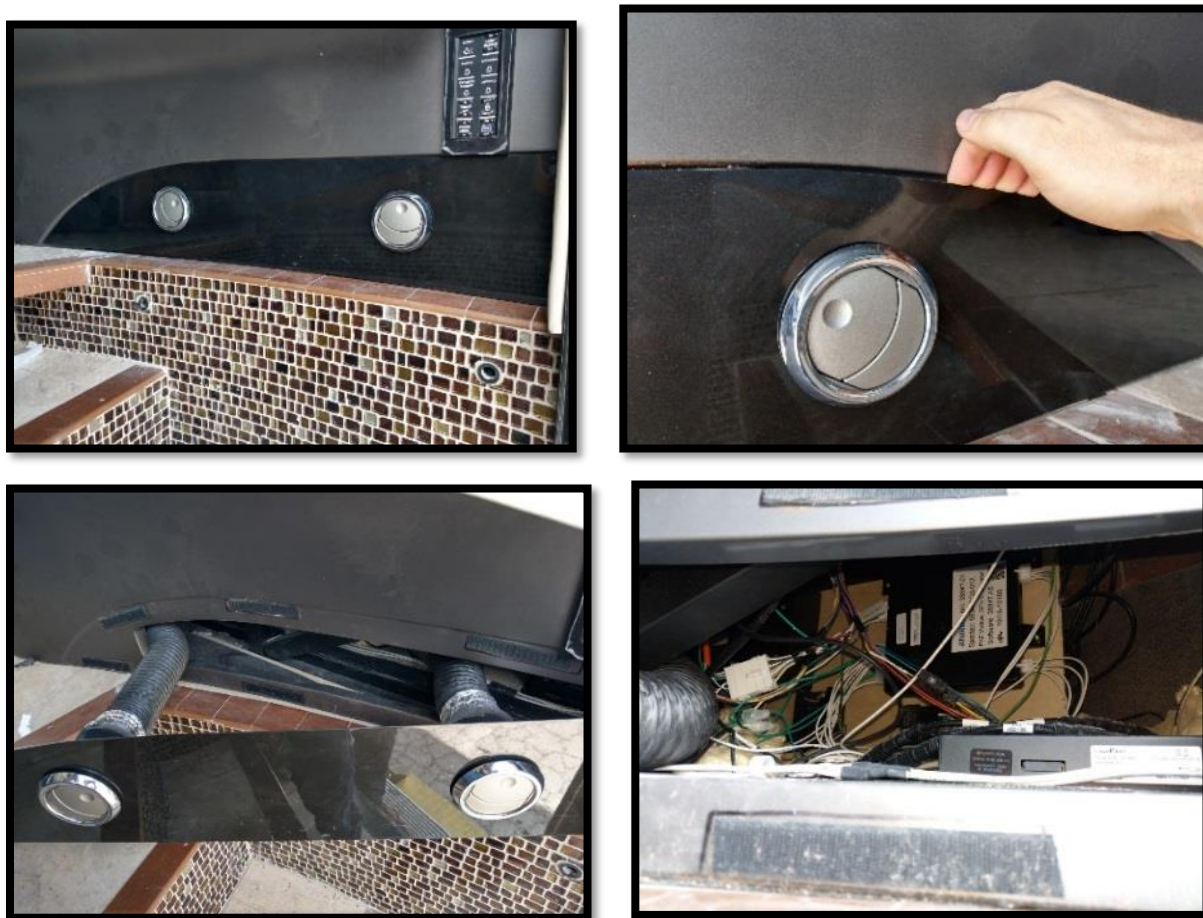
FIG. 4-1

Note: Items depicted in pictures are for reference only and are showing a Foretravel motor coach location. The Trimark Module is located behind the Velcro attached lower dash cover forward of entry step. Refer to FIG. 4-1.

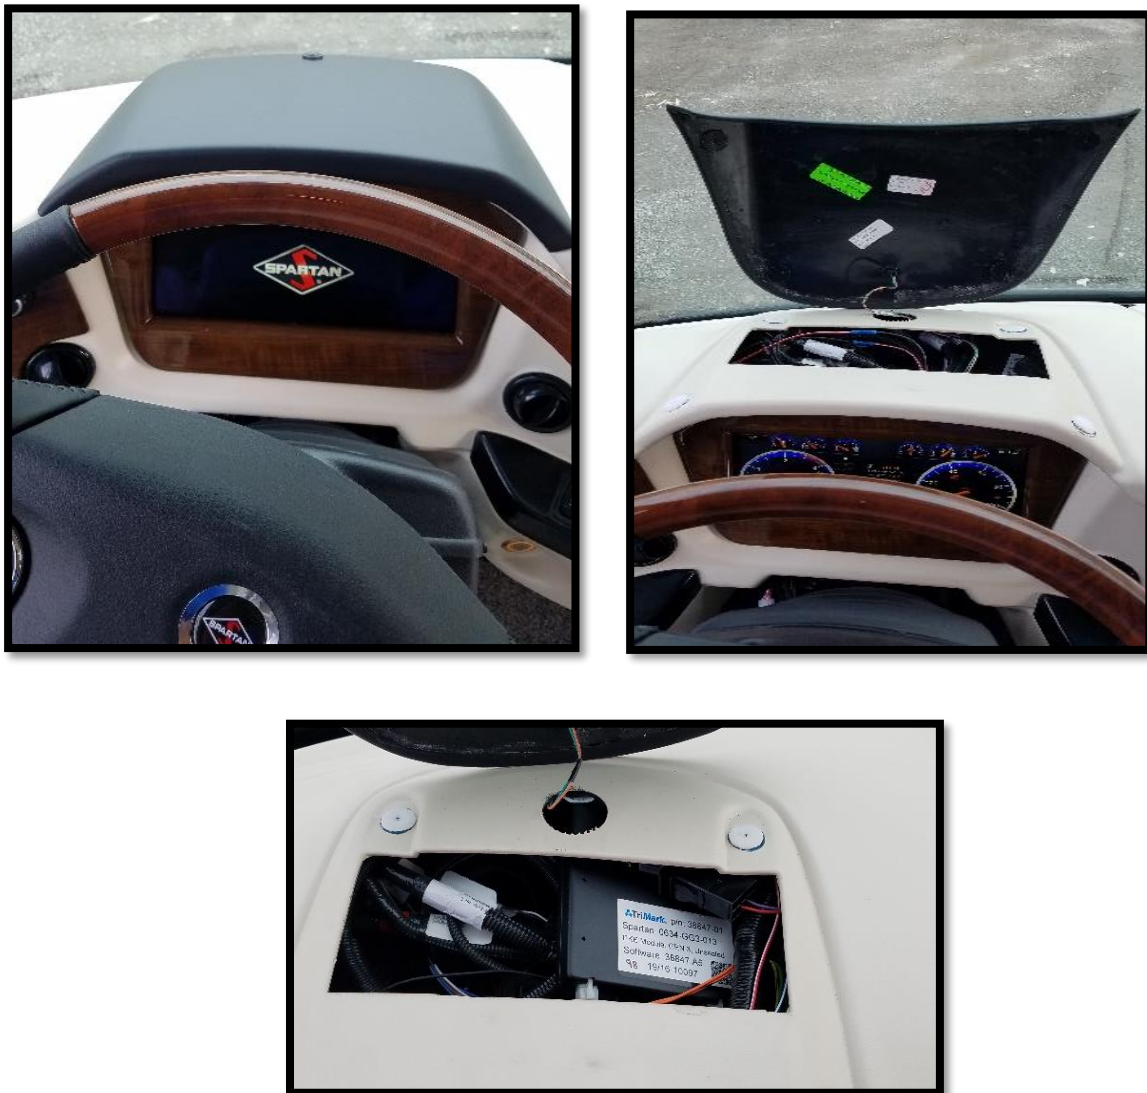
FIG. 6-1

Note: Items depicted in pictures are for reference only and are showing a Newmar motor coach location. The Trimark Module is located under the Velcro attached dash cover forward of the instrument panel. (Use caution when removing the cover making sure not to unplug the ambient light sensor). Refer to FIG. 6-1.
