PRODUCT CAMPAIGN BULLETIN

NUMBER: WUX-09R

SUBJECT: 2016-2017 Outback Replacement
Airbag Control Module

NHTSA ID: 19V910

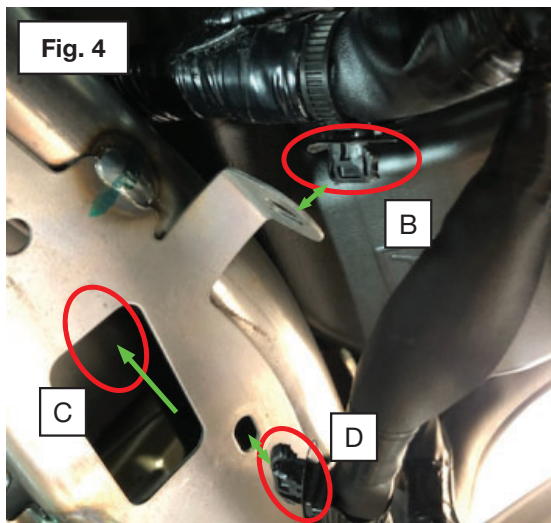
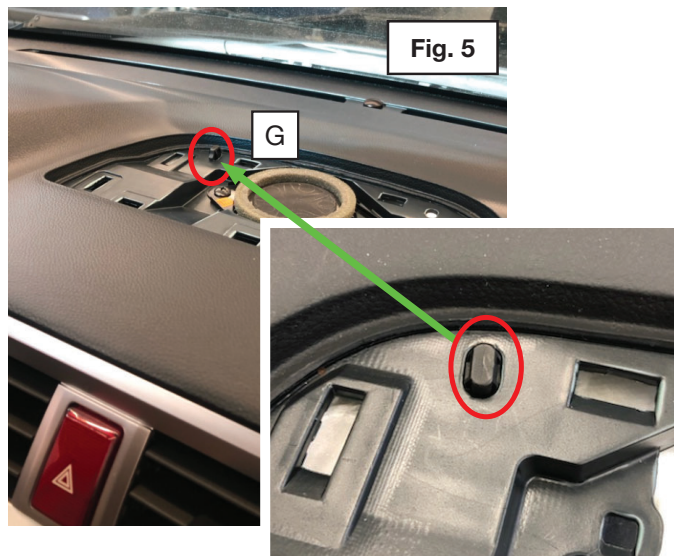
- **CAREFULLY** release the plastic retaining clips securing the IP wiring harness in the 7 locations shown below using a needle-nosed plier or trim clip removal tool. Use the overall photo (Fig. 1) shown below for clip location reference and the rest of the photos for specifics. Releasing these clips provides additional access to get the airbag module past the harness. Fig. 2 shows clip A on a brace adjacent to the airbag module. Figs. 3 and 4 show the same clips (B, C & D) but the photos were taken from different angles.

Fig. 5 shows clip G under the IP top center speaker grille. Figs. 6 & 7 show clips E & F securing the harness to braces in the center of the IP near the storage box below the audio unit and HVAC controls.

IMPORTANT NOTE: Since clip D is not accessible from behind to release it and will most likely be damaged during removal, a replacement is included in the box along with the new replacement airbag module.
