SERVICE INFORMATION BULLETIN

APPLICABILITY: 2019MY Legacy and Outback w/ 8-in. Navi System **NUMBER:** 15-255-19R
 2019-20MY Impreza and Crosstrek w/ 8-in. Navi System **DATE:** 11-08-19
 2019-20MY Crosstrek Hybrid w/ 8-in. Navi System **REVISED:** 01-28-20
 2019-20MY Forester w/ 8-in. Navi System
 2019-20MY WRX WRX STI w/ 7-in. Navi System
 2019-20MY Ascent w/ 8-in. Navi System
 2019-20MY BRZ with 7-in. Navi System

SUBJECT: Map Data Update Procedure for Harman Gen 3.1 Navigation Equipped Head Units (H/U)

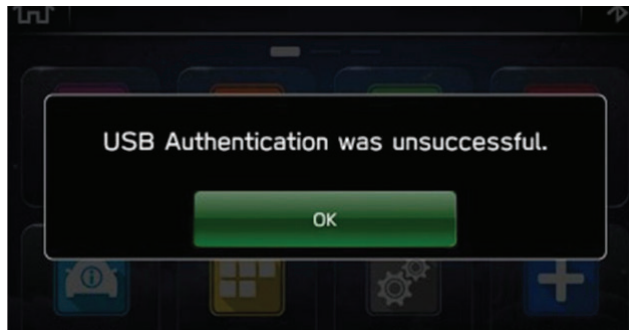
CAUTION: NEVER attempt to install this software update on any 2017 or 2018 MY vehicles as they are equipped with Gen 3.0 Navigation systems. This update is **ONLY** for models equipped with **Gen 3.1** Navigation systems. Should an attempt be made to install any of these files into a Gen 3.0 H/U, the USB Authentication error screen below will be displayed.

- The USB Authentication error screen will also be displayed when attempting to install the map data bundled with a software version older than the version already installed in the H/U.
- Move the vehicle to an outside location where the engine can be safely started and kept idling during the update process.
- Never idle the vehicle in a closed space such as a garage, even if the garage door is open.
- Once the vehicle is in a safe location, be sure the vehicle is in Park if CVT or Neutral if MT and the parking brake is fully engaged.
- Unplug any cables or available devices from the USB ports.
