SERVICE BULLETIN

APPLICABILITY: 2016-18MY Forester 2.0L DIT
 2017-19MY WRX
 2019-20MY Ascent

NUMBER: 11-195-20

SUBJECT: PCV Vacuum Hose Assembly- Design Change

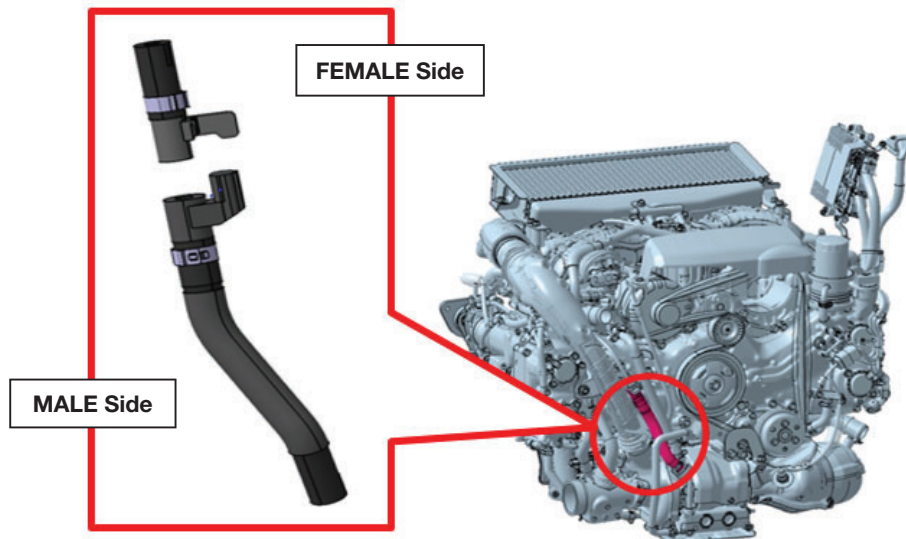
This bulletin announces availability of a new vacuum hose assembly for the positive crankcase ventilation (PCV) system incorporating improved sealing to prevent potential oil seepage which could come from the connection point. Whenever oil seepage is confirmed at the connection point, always replace the Male section. The female section does not always need to be replaced unless damage is confirmed.

- Both Male and Female sections of the hose (with connectors installed) are available separately.
- Always replace the Male section whenever oil seepage is confirmed at the connection point. The female section does not always need to be replaced unless damage is confirmed.
- Always order the most up-to-date replacement parts based on the specific VIN being repaired.
