SERVICE BULLETIN

APPLICABILITY: 2012-19MY Legacy and Outback
 2014-16MY Impreza
 2014-17 Crosstrek
 2012-18MY Forester
 2014-19MY WRX and WRX STI

NUMBER: 07-152-19R

SUBJECT: Power Window Switch Changes

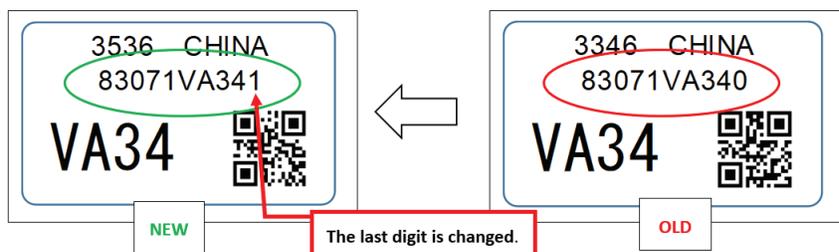
Use the part number on the label to distinguish between the old and new switches as shown below:

When diagnosis identifies a faulty Power Window switch, use the table below for determining which switch(s) to order and replace.
